2006 BRIDGE INSPECTION

CASCADE BRIDGE

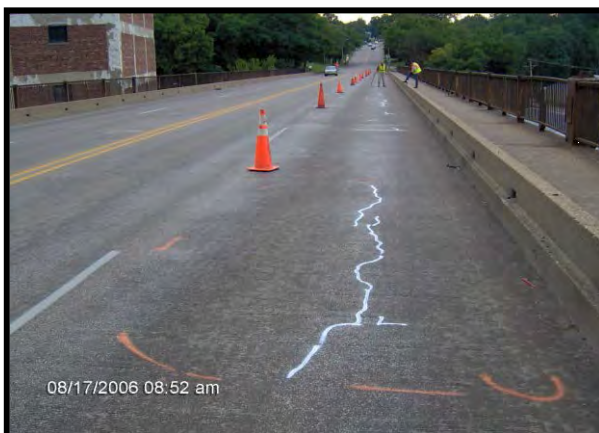
Mt. Pleasant Street Overpass Profilograph Results Tested 6-4-07

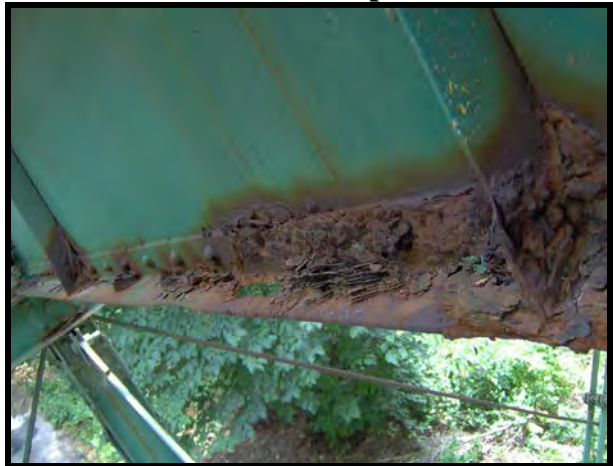
FB #2 6^L9 (W) of (E) truss 1½' x 7" hole rusted through bottom outstanding angle leg to (N) Span #4.

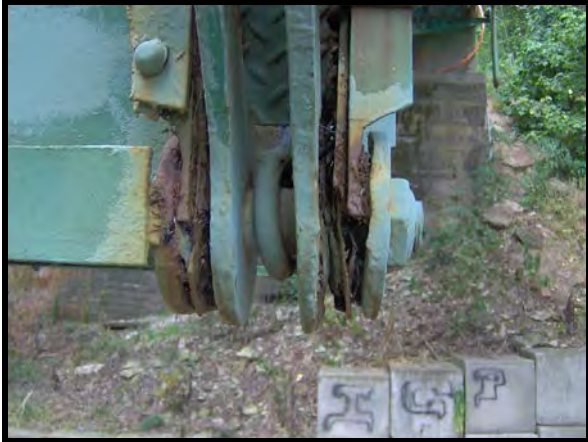
Joint L₁ (E) truss Span #4 1/8 ± plate is left that connects L₁ U₁ to the pin.

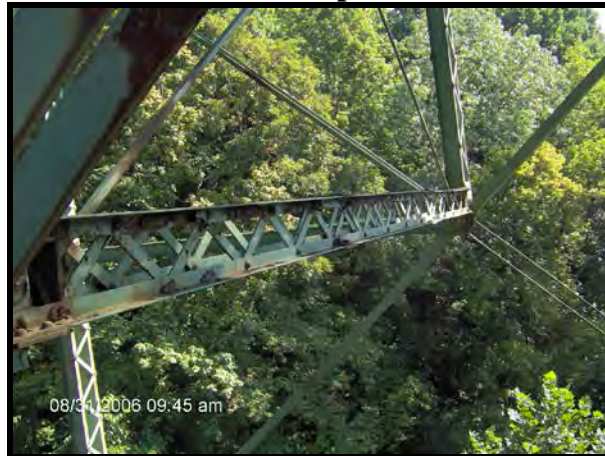
Member M₅ (W) truss to member M₅ (E) truss is rusted with approximately 10% section loss.

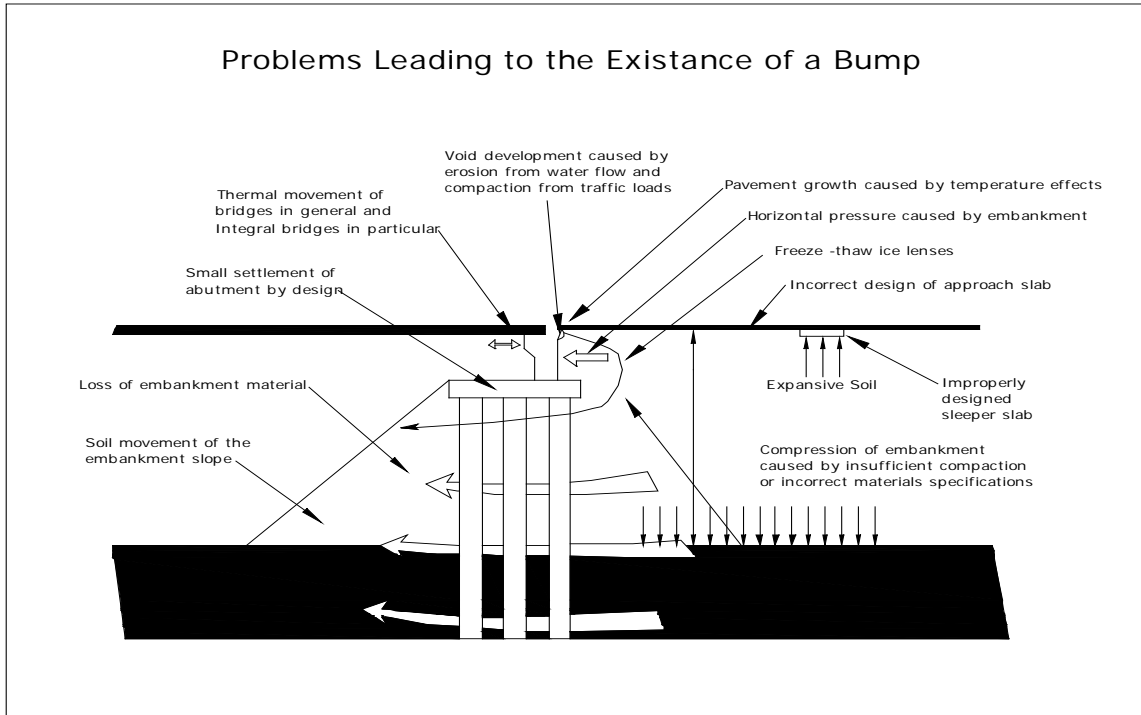
Three of Burlington's bridges have this type of abutment; they are

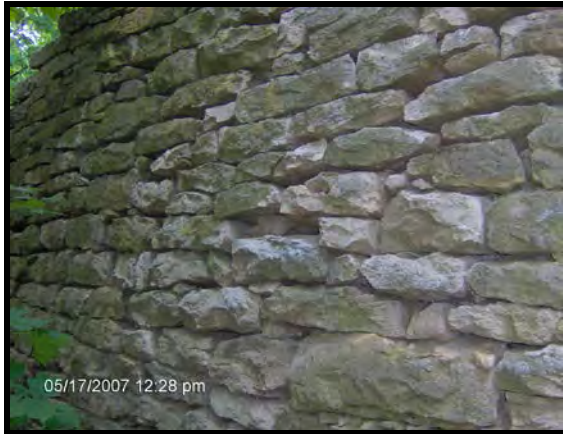
South Abutment stones falling out.

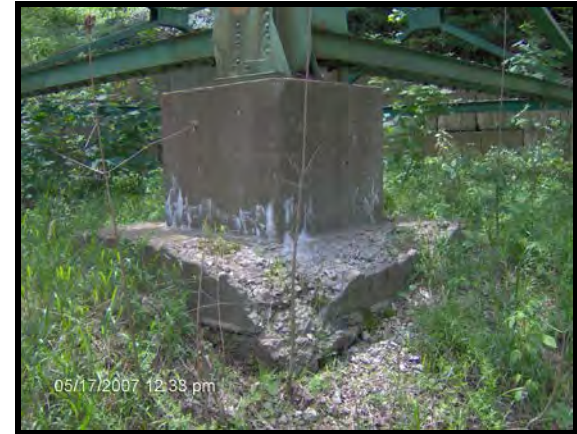
First Pier spalled pier caps.

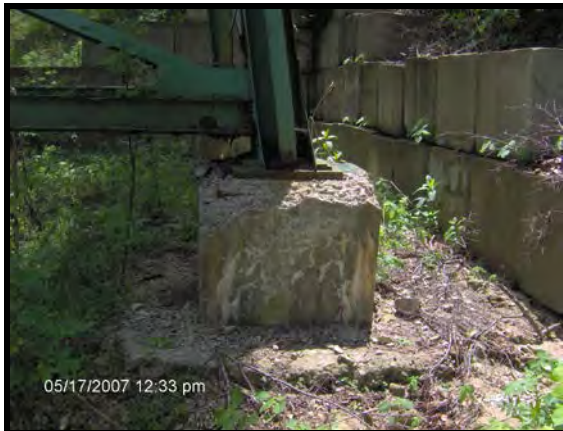
First Pier spalled pier caps.

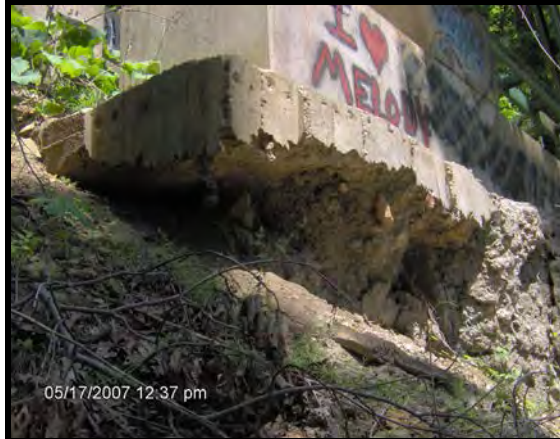
Third Pier void under west side of Pier Cap.
