# Cascade Bridge Rehabilitation Evaluation

PREPARED FOR  
CITY OF BURLINGTON  
DEPARTMENT OF PUBLIC WORKS

SEPTEMBER 2012

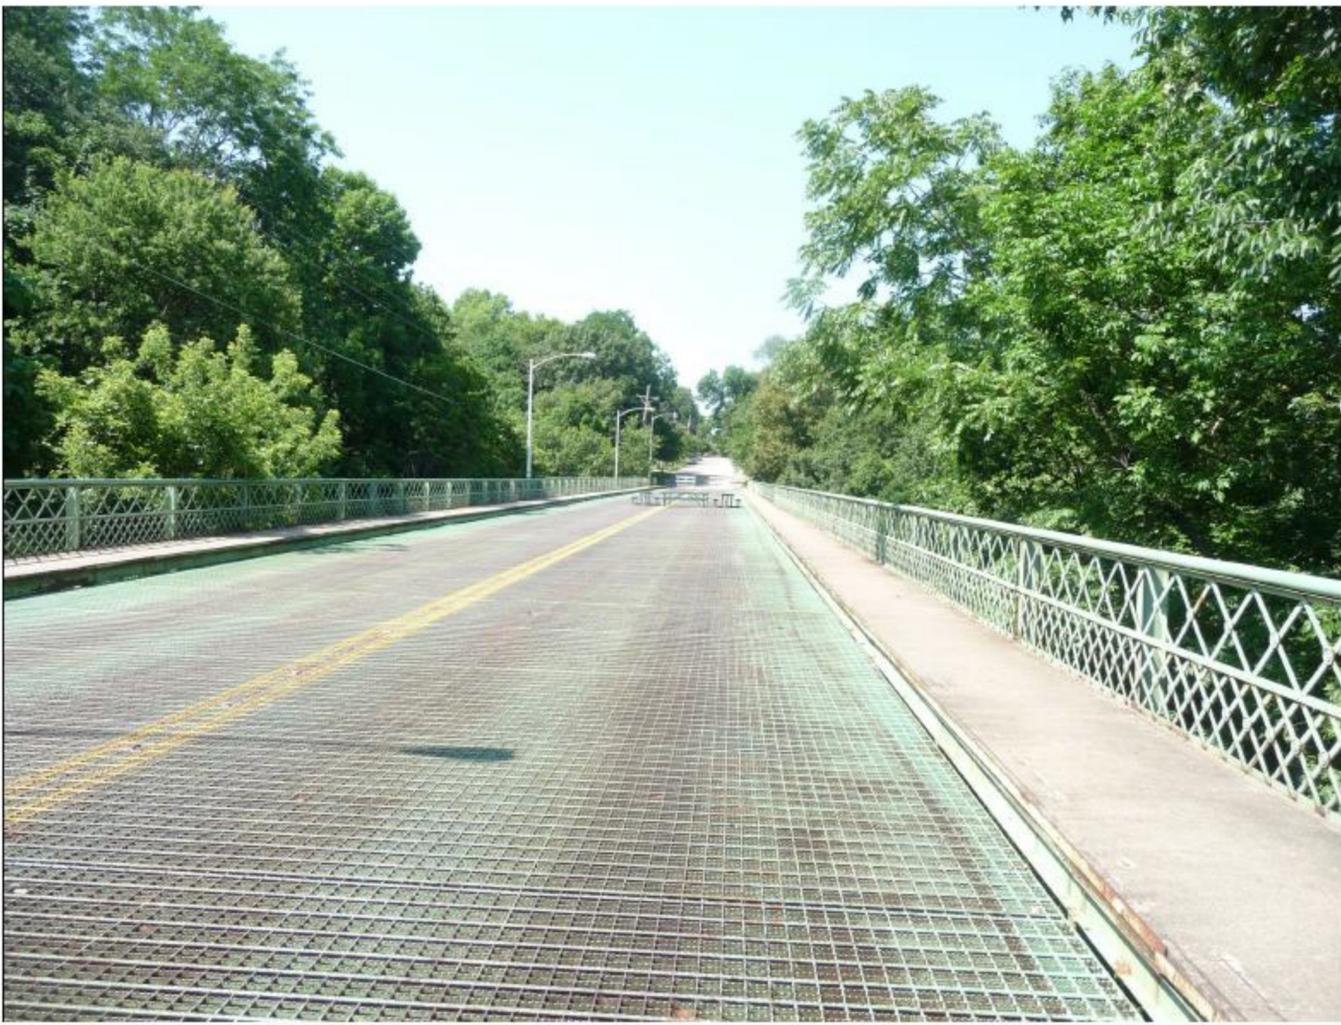
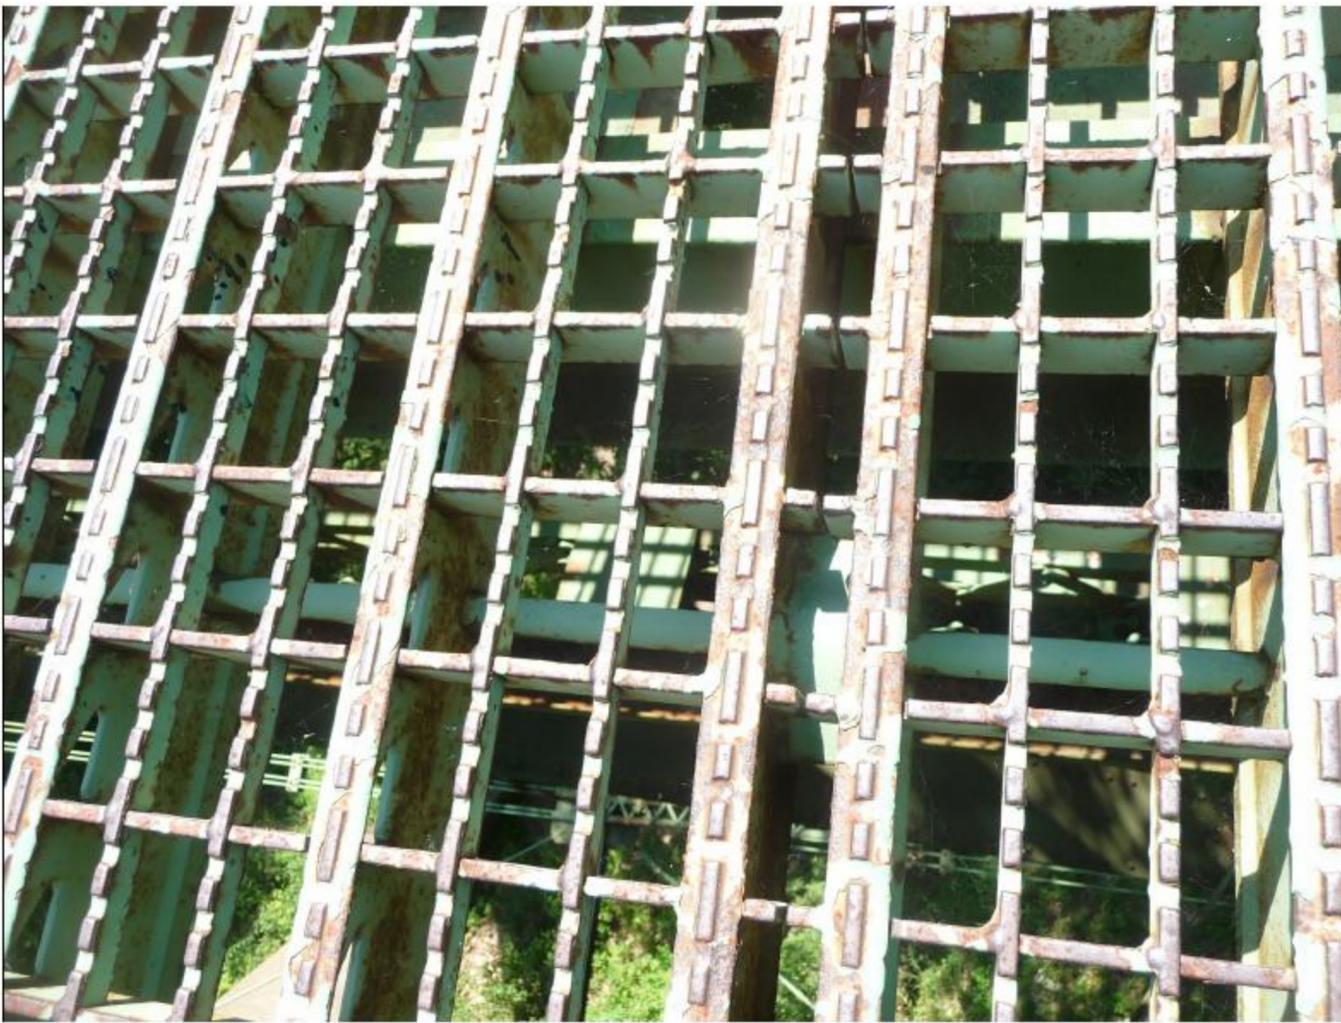
The 5" steel roadway deck grating was installed in 1964. The steel deck is lighter than the original timber deck, thereby reducing the weight of dead load on the trusses. Deck drainage is not controlled, as water runs freely through the open steel deck. The steel deck appears to be in reasonably good condition (**see Photo A1, A2**).

The 5 inch steel roadway deck grating appears to be in generally good condition and no repairs are recommended at this time. However, we recommend removing and reinstalling the finger joints at the south abutment to provide adequate clearance for thermal expansion and contraction.

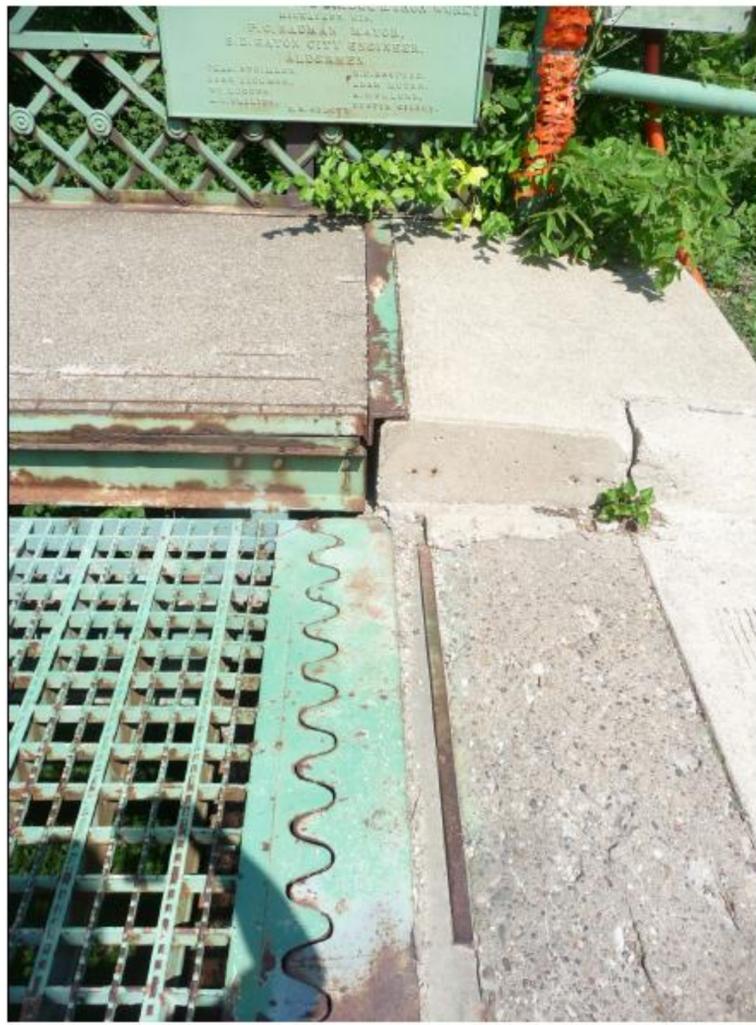
**A3**

The temperature at the time of the site observation was approximately 90 degrees F. The finger joint plates at the south abutment roadway expansion joint were in contact with each other (**see Photo A3**). There was a gap observed in the deck joint openings at the Pier 1 (**see Photo A4**) and north abutment roadway expansion joints (**see Photo A5**).

locations of deterioration were observed, and several areas near the curb face exhibit exposed reinforcing steel (**see Photo B1**). The adjoining sidewalk deck segments and/or cover plates, are in contact with each other (see Photos A3, A4, and A5), indicating an inadequate joint capacity for thermal movement.

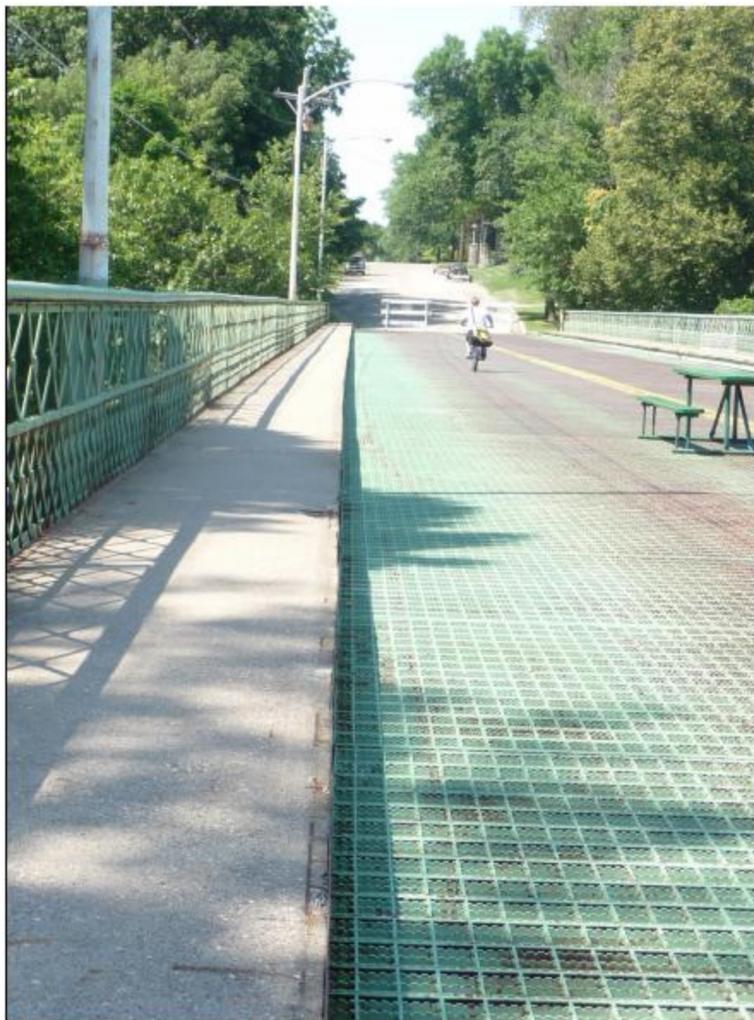
**B1**

The concrete sidewalk appears to be generally in fair condition, although the deck was not sounded to locate hollow or delaminated areas. Several isolated

The concrete sidewalks and steel framing must be removed to accommodate a sidewalk that meets current ADA requirements, and to correct the severe corrosion and section loss observed in some of the steel supporting members. Although removal and reconstruction of both sidewalks is not necessary to meet ADA requirements, it is included in our cost estimate to represent a worst case scenario and to provide an allowance for sidewalk framing repairs that might be needed due to severe corrosion. The new sidewalk travel surface must have a width of at least 5'-0". Based on the new sidewalk width requirement, and the observed significant deterioration of some existing sidewalk framing members, we are assuming that all sidewalk framing members will need to be replaced. The new support framing will be constructed of new structural steel members using a configuration similar to the existing framing. A corrugated steel deck with concrete topping, similar to the existing sidewalk, is recommended to minimize weight. New expansion joints of similar construction to existing will be incorporated into the new sidewalk. Any existing framing members found to be in reasonably good condition during repair plan development can be re-used. A concept detail of the new sidewalk configuration and framing is included in the Appendix of this report.

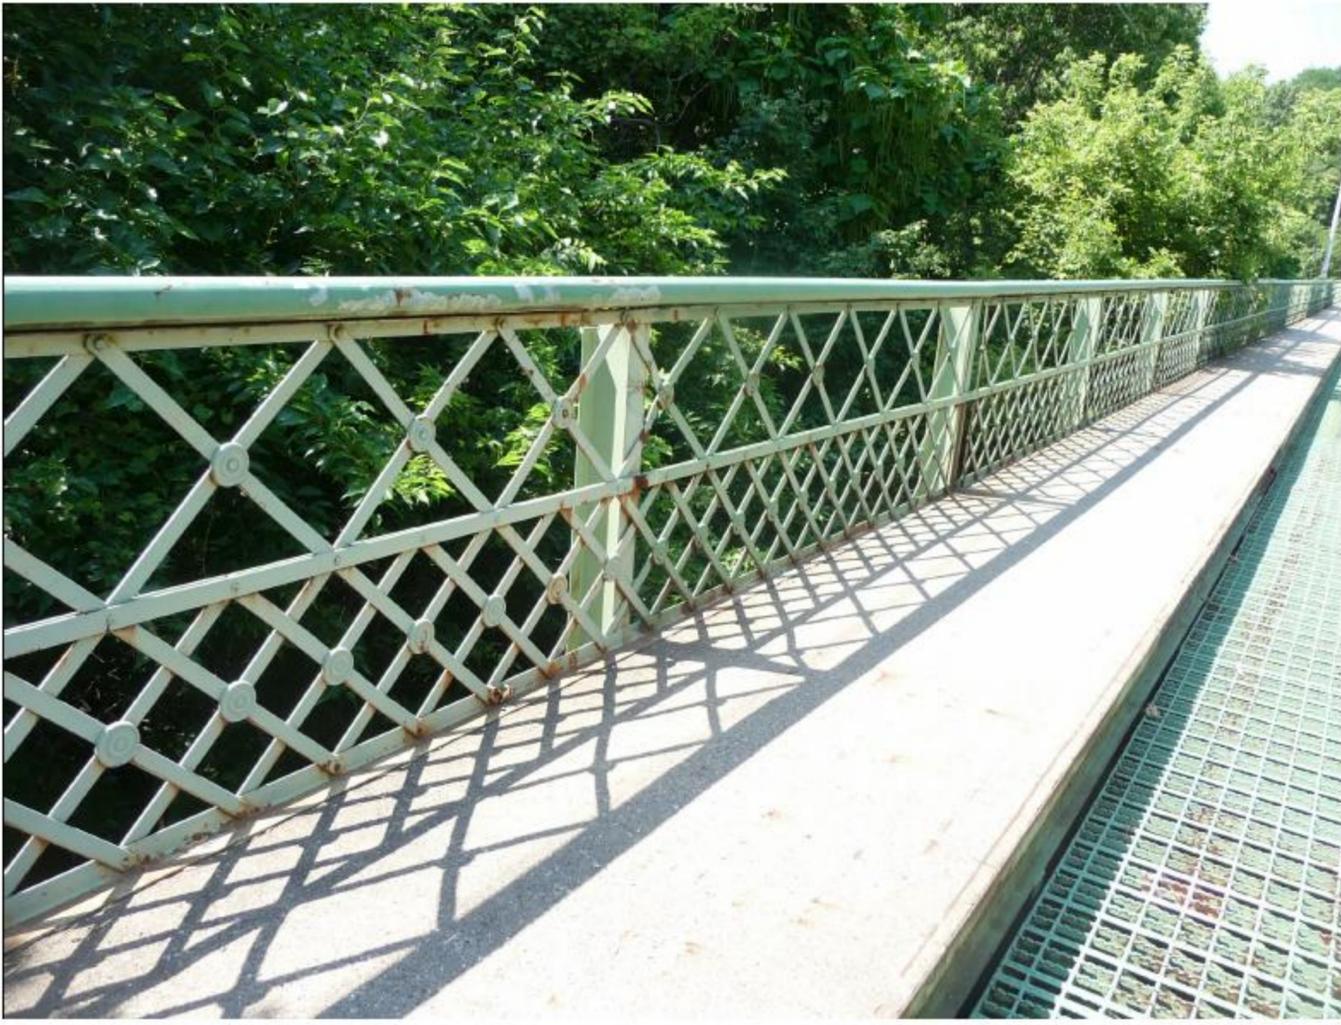
**C1**

Previous repair plans indicate that the original sidewalk rail was removed and reinstalled as part of the sidewalk reconstruction (**see Photo C1**). The rail height measures approximately 38 inches above the sidewalk surface. The current minimum design height for pedestrian railing is 42 inches, per the AASHTO LRFD Bridge Design Specifications. In addition, the rail does not meet the geometrical spacing restrictions of a 6-inch sphere for the lower 27 inches of railing, and an 8-inch sphere for the upper portion.

The rail appears to be in generally good condition, but exhibits paint deterioration with many locations of rust.

The sidewalk rail should be fully shop blasted and repainted at this time. Rail elements found to be damaged should be repaired or replaced.

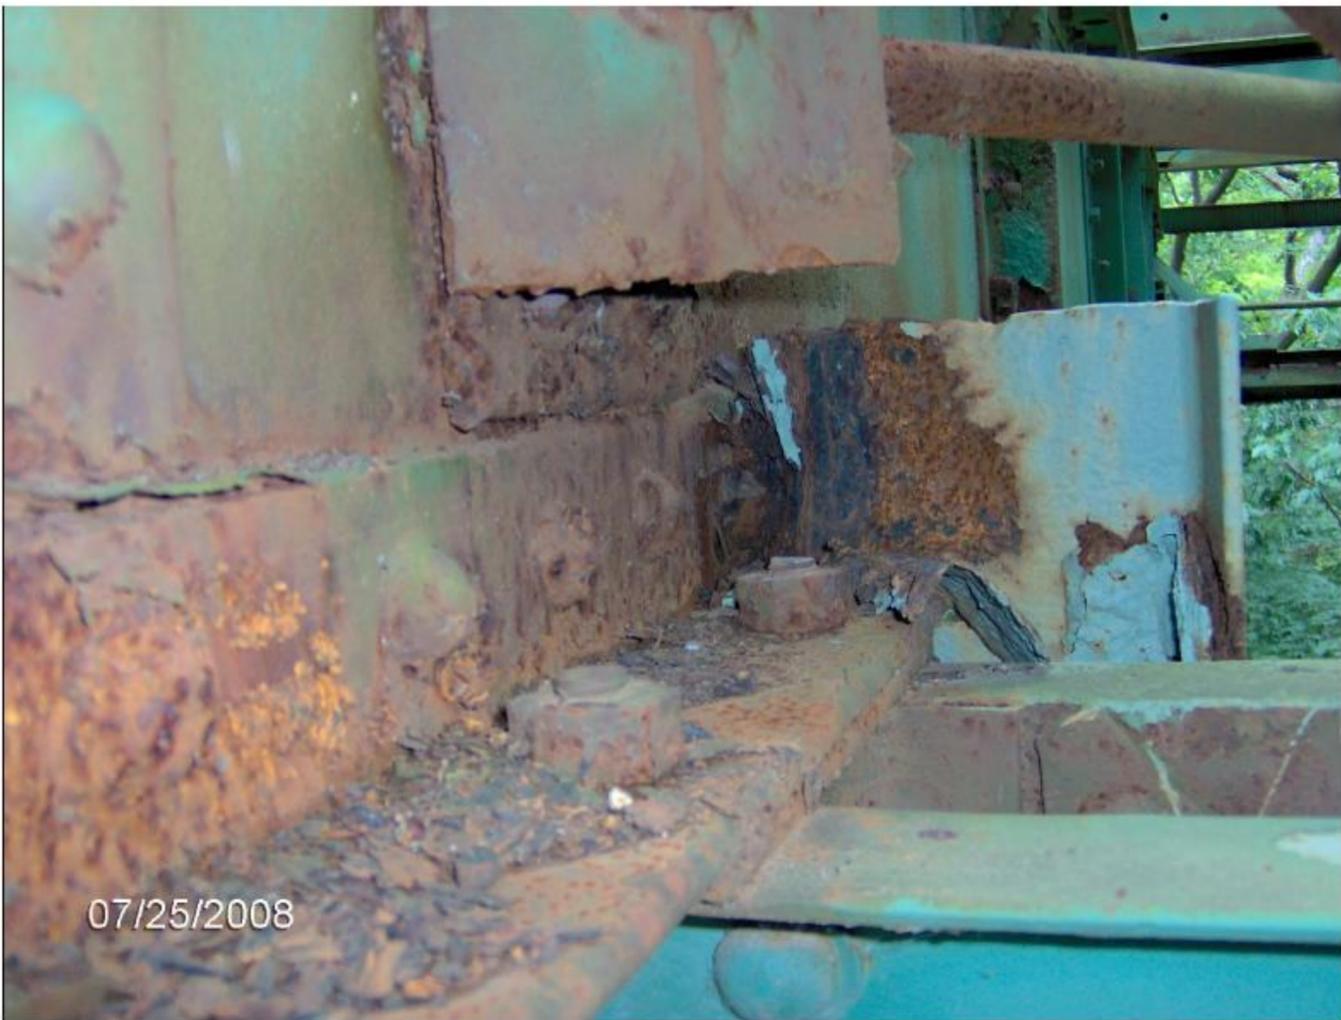
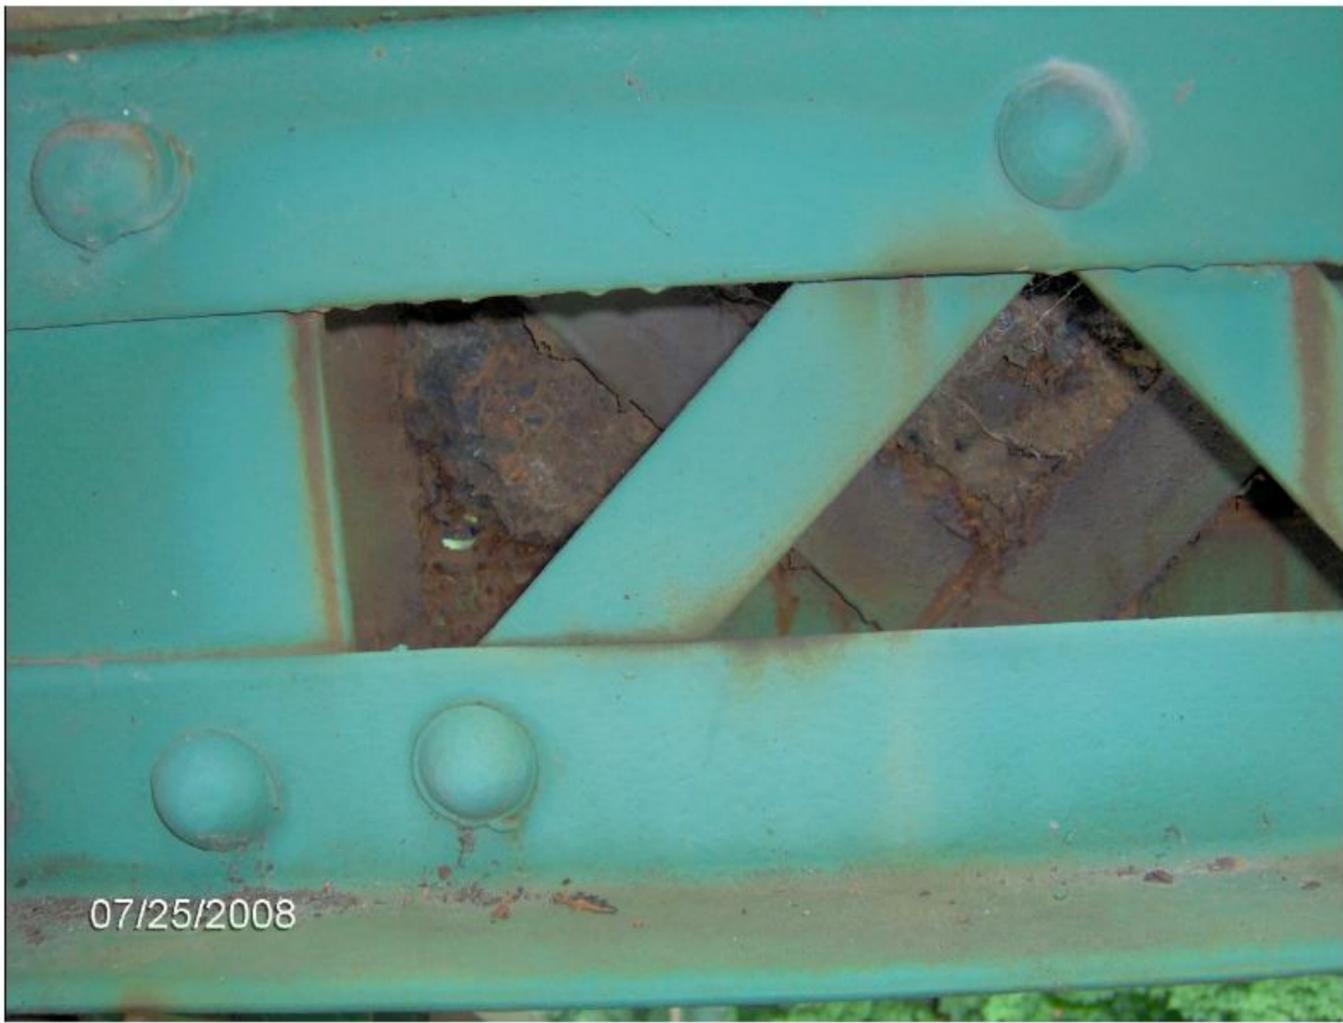
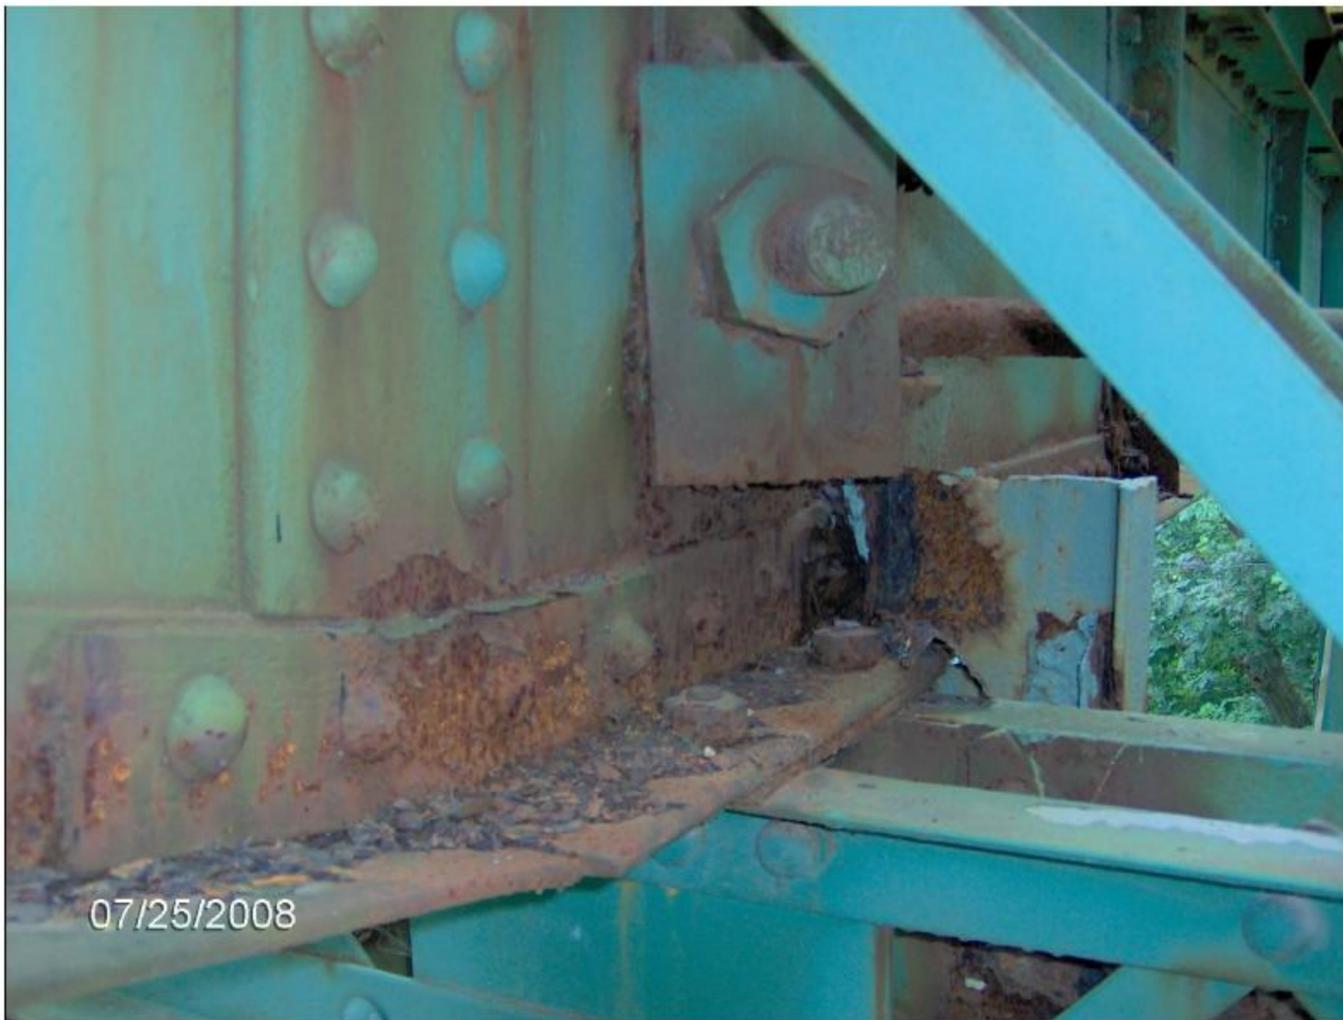
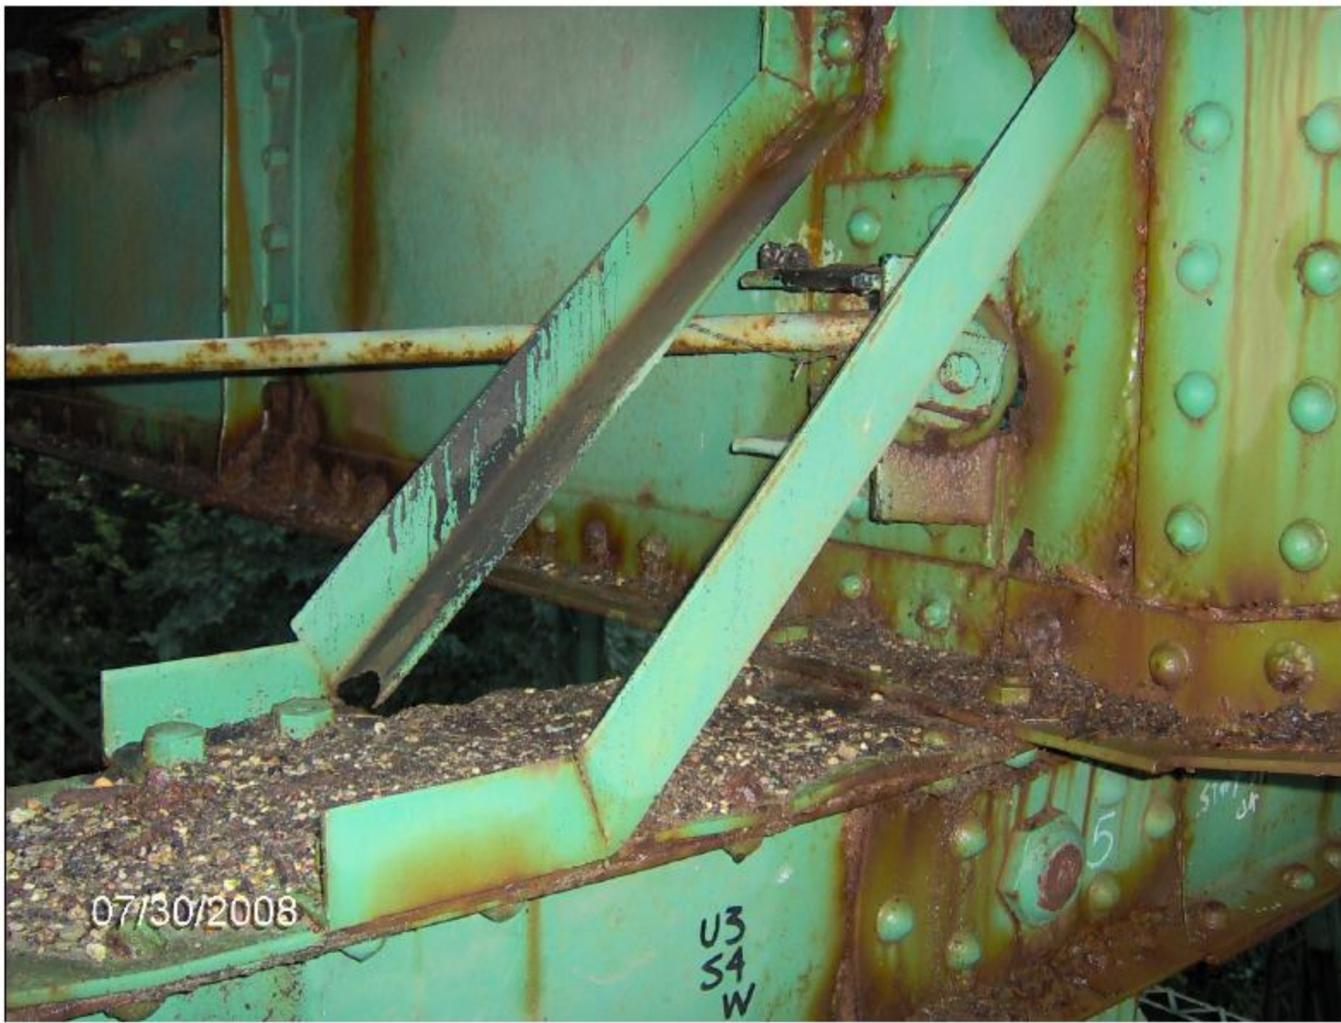
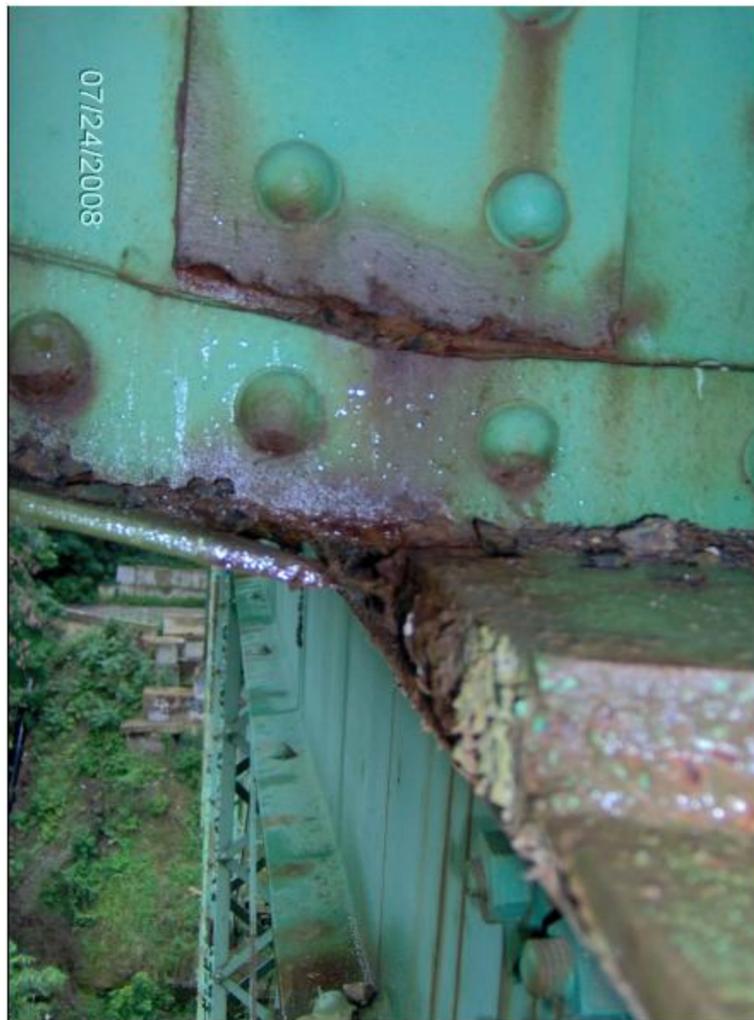
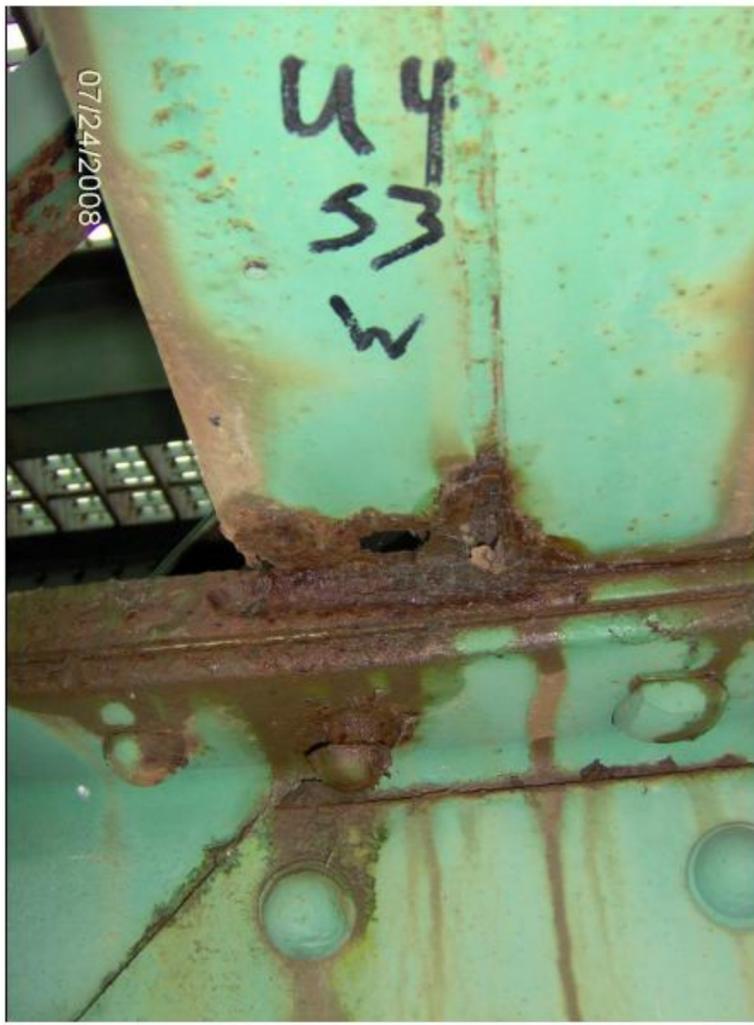
Floorbeams are built-up riveted sections utilizing steel plates as webs and steel angles as flanges. Wide-flange members were welded to the tops of the floorbeams during the deck replacement when the original deck stringer bolsters were removed. The floorbeams cantilever approximately 8 feet beyond the centerline of each truss, with the depth of the cantilever tapering. The cantilever section supports one deck stringer and the sidewalk framing. Previous inspections indicate deformations in built-up members due to pack rust, complete

section loss of flanges for significant length of floorbeams, and areas of severe section loss of flanges and webs (**see Photos D1, D2, D3, D4, D5, D6**). A review of the photos indicates significant corrosion and section loss in the areas of high stress at the ends of cantilevers.

Deteriorated sections of floorbeams, primarily flange sections, should be repaired. Based on available information from previous inspection reports, an allowance of 10% of steel weight of floorbeams is included for replacement. Actual locations of steel repairs will be identified during the repair plan development.

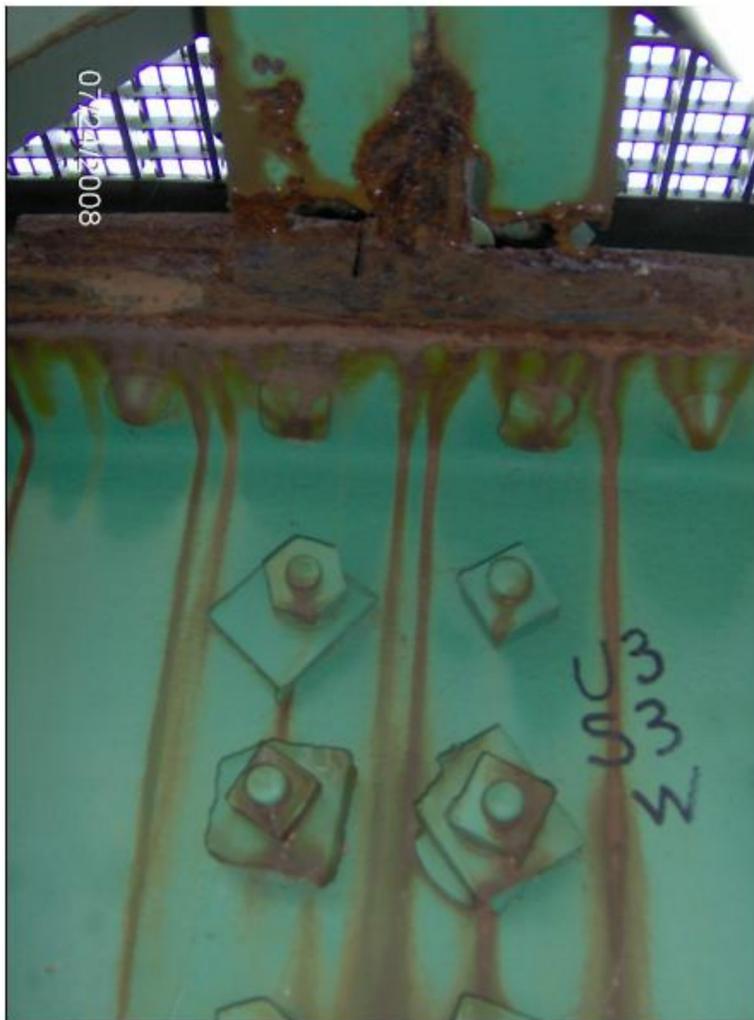
**D7**

Some deck stringers are original double-channel members, and others are wide-flange members that were installed to replace some of the original smaller stringers during the deck replacement. Previous inspections indicate significant section loss, pack rust beneath splice plates, gusset plates supporting stringers perforated due to corrosion, and broken welds at splice plates due to corrosion (**see Photo D7**).

Deteriorated sections of deck stringers should be repaired. Stringers with extensive deterioration should be replaced. Based on available information from previous inspection reports, an allowance of 10% of steel weight of floorbeams is included for replacement. Actual locations of steel repairs will be identified during the repair plan development. It is intended that stringer replacements could be accomplished without removing the steel roadway deck.

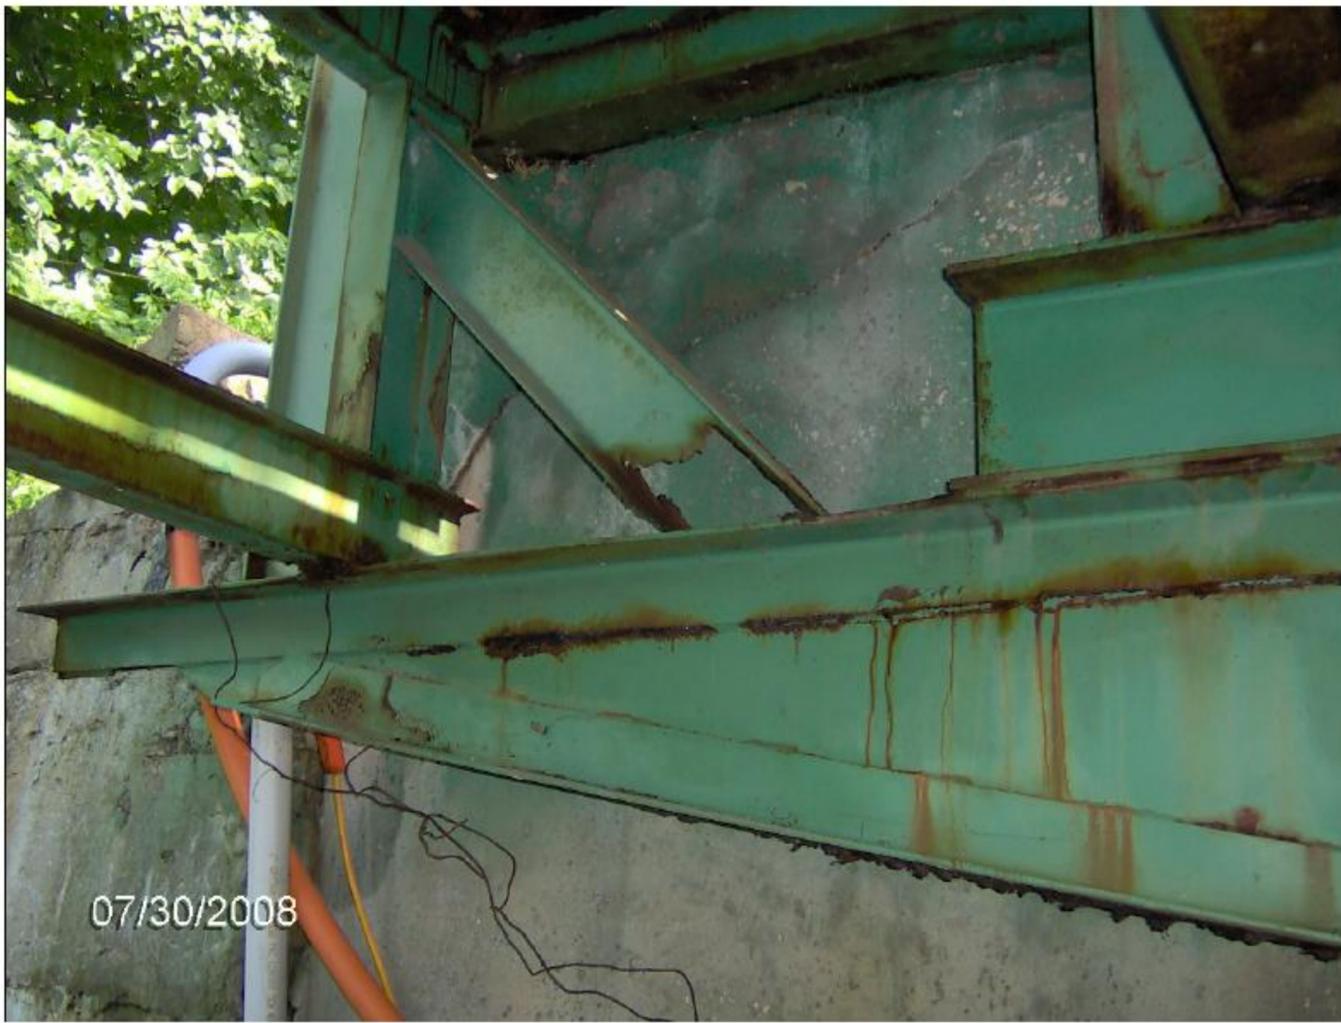
**D8**

Sidewalk framing consists of I-shaped members that were originally used as deck stringers. The deck stringers were salvaged during the deck replacement for the purpose of sidewalk framing. There is minimal information regarding their condition in the previous inspection reports. However, these members exhibit severe section loss and corrosion in some of the previous inspection photos (**see Photo D8**).

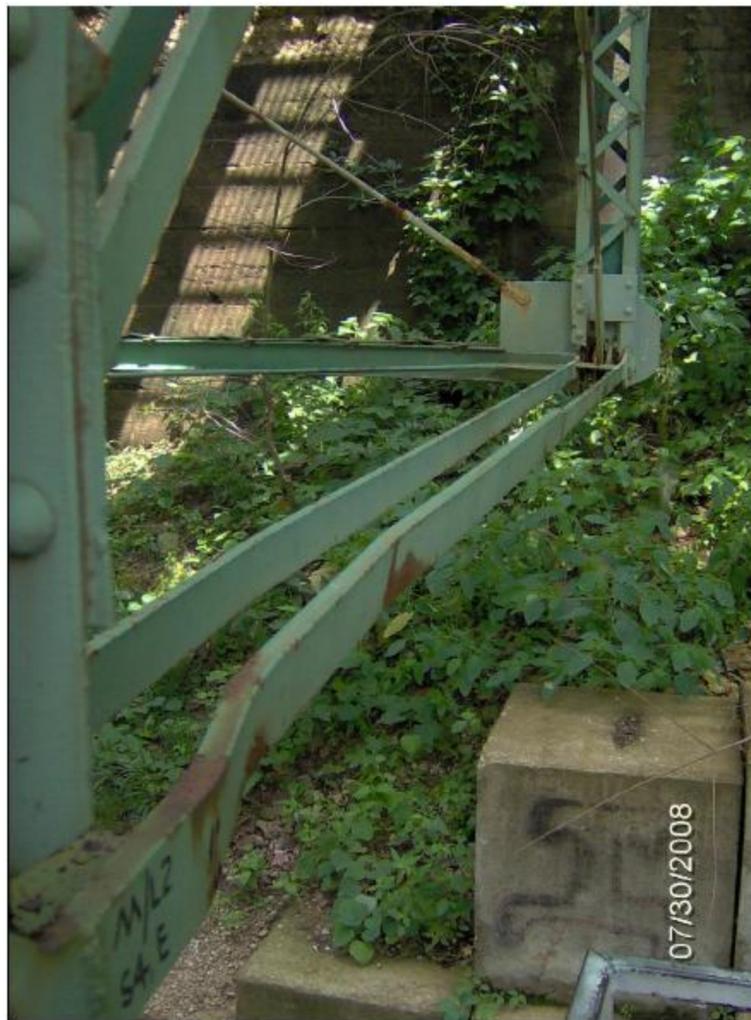
**E1\_1**

Previous inspection reports indicate several deficiencies relating to the truss eyebars. Severe section loss is common. Many tension members consist of sets of at least two eyebars between panel points, and bottom chord members of span 3 consist of sets of four eyebars. Many sets of eyebars were observed with “slack” in at least one of the eyebars – meaning that some of the eyebars were not carrying the tension load for which they were designed, and the adjacent eyebars in that set were carrying more tension load than they were designed to carry. This is readily apparent when observing the structure, but is difficult to

discern in the available photos. A damaged eyebar that was bent, possibly caused by impact, results in a more extreme example of this situation (**see Photo E1.1**).

Based on the high levels of deterioration and corrosion at panel points, the inaccessibility of eyebar and rod ends for inspection and monitoring to ensure public safety, and the high stresses common to all eyebar ends, in addition to the low allowable stress of the eyebars, we recommend that all eyebars and rods be replaced with similar elements using modern materials.

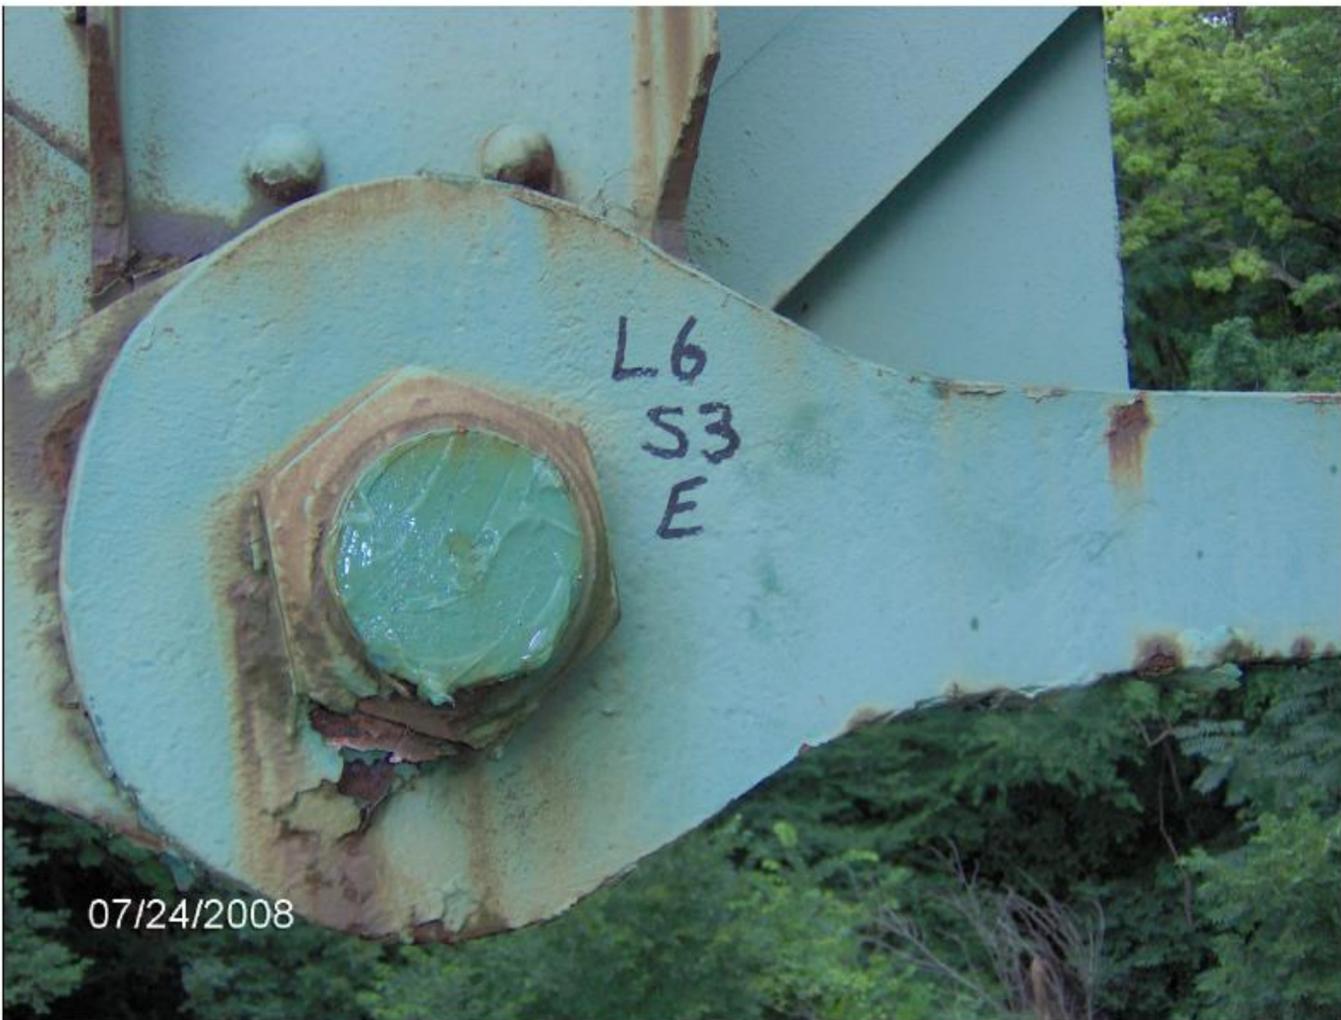
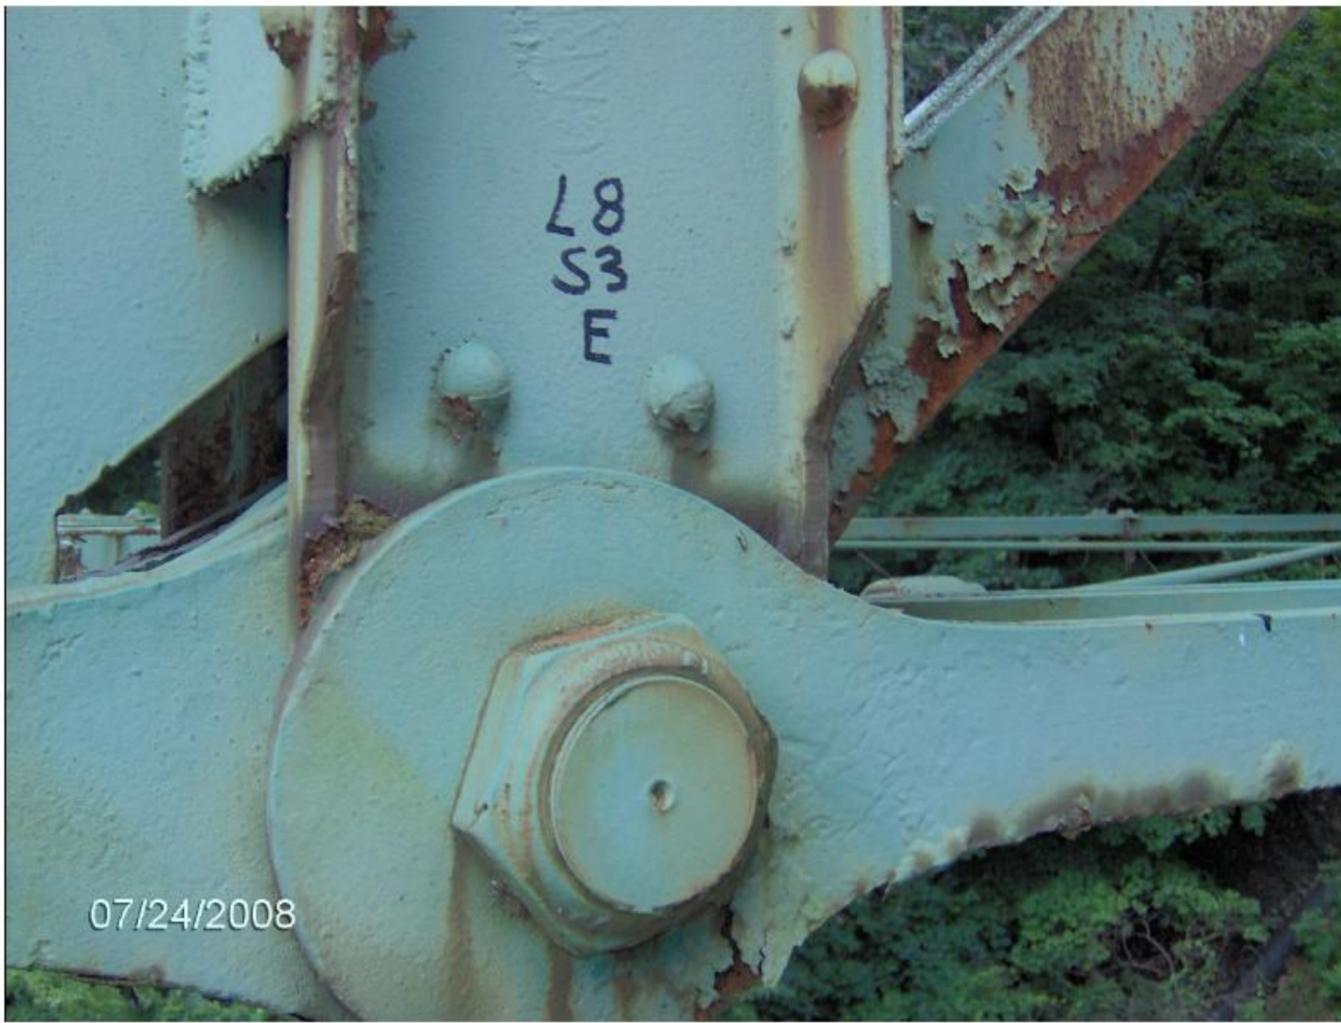
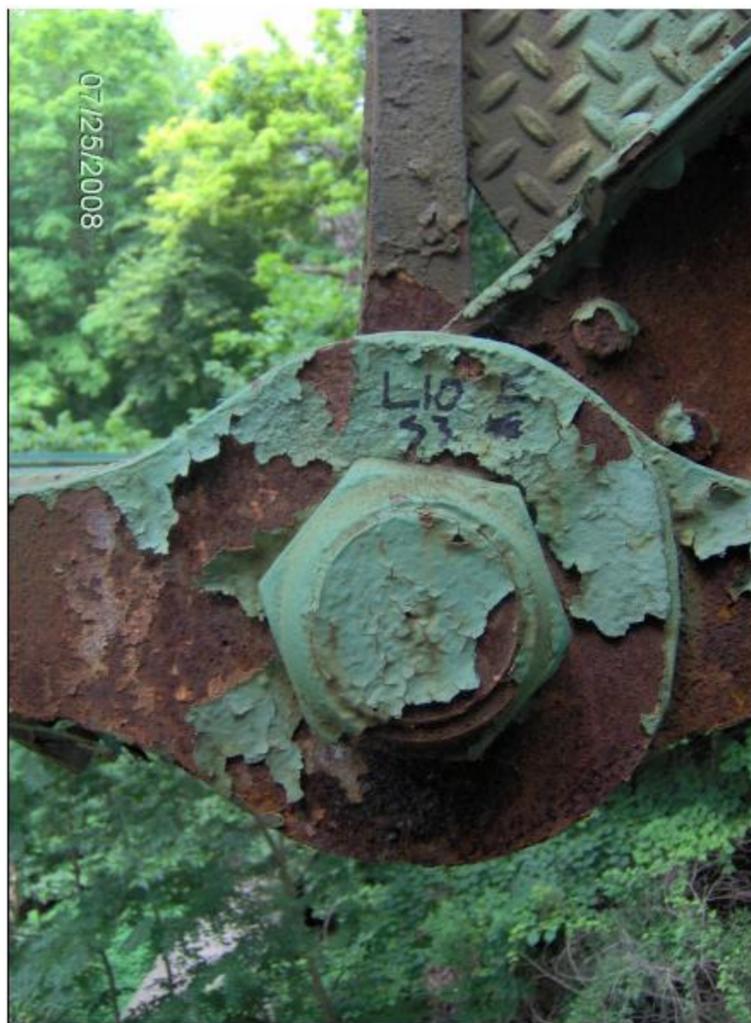
Eyebars exhibit significant corrosion at panel points (**see Photos E1.2 thru E1.10**). The 1953 repair plans include details to reinforce some of the diagonal eyebar ends of span 3 (**see Photo E1.11 thru E1.13**); but it does not appear that the details were implemented on all diagonal eyebars. The 1964/1978/1984 repair plans include similar details for diagonal eyebar reinforcement, but intended locations of repairs are not indicated in the plans. It does not appear that the details were implemented on all diagonal eyebars in other spans. The reinforcement details include an eyebar reinforcement plate welded to the end of the eyebar, and also supplemental plates welded between existing compression member elements or eyebars at the panel points, to which the eyebar reinforcement plate is welded. The effectiveness of this detail is questionable, given that the reinforcing plate utilized is welded to other eyebars at the panel point, or that the load path is not a direct transmission to the panel point. The 1964/1978/1984 repair plans also include details to seal weld the top perimeter of all adjoining eyebars and gusset plates at bottom panel point locations (**see Photo E1.14**).
