# Cascade Bridge Rehabilitation Evaluation

PREPARED FOR  
CITY OF BURLINGTON  
DEPARTMENT OF PUBLIC WORKS

SEPTEMBER 2012

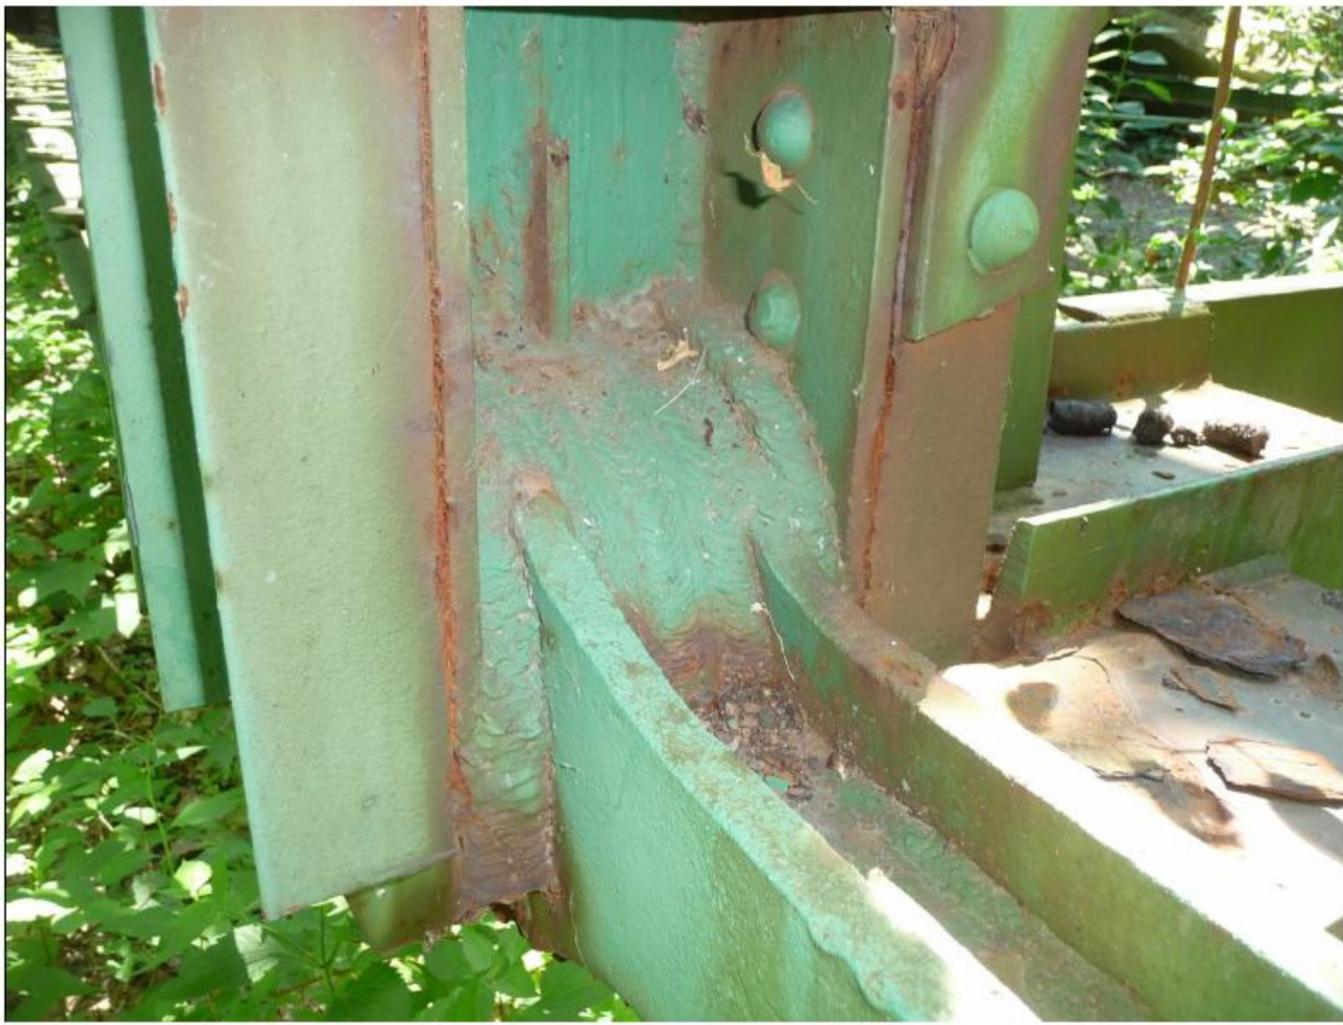
**E1\_14**

Eyebars exhibit significant corrosion at panel points (**see Photos E1.2 thru E1.10**). The 1953 repair plans include details to reinforce some of the diagonal eyebar ends of span 3 (**see Photo E1.11 thru E1.13**); but it does not appear that the details were implemented on all diagonal eyebars. The 1964/1978/1984 repair plans include similar details for diagonal eyebar reinforcement, but intended locations of repairs are not indicated in the plans. It does not appear that the details were implemented on all diagonal eyebars in other spans. The reinforcement details include an eyebar reinforcement plate welded to the end of the eyebar, and also supplemental plates welded between existing compression member elements or eyebars at the panel points, to which the eyebar reinforcement plate is welded. The effectiveness of this detail is questionable, given that the reinforcing plate utilized is welded to other eyebars at the panel point, or that the load path is not a direct transmission to the panel point. The 1964/1978/1984 repair plans also include details to seal weld the top perimeter of all adjoining eyebars and gusset plates at bottom panel point locations (**see Photo E1.14**).

The pins and gusset plates at panel points should be replaced, and the bracing connections should be reconfigured to prevent interference with member rotation.

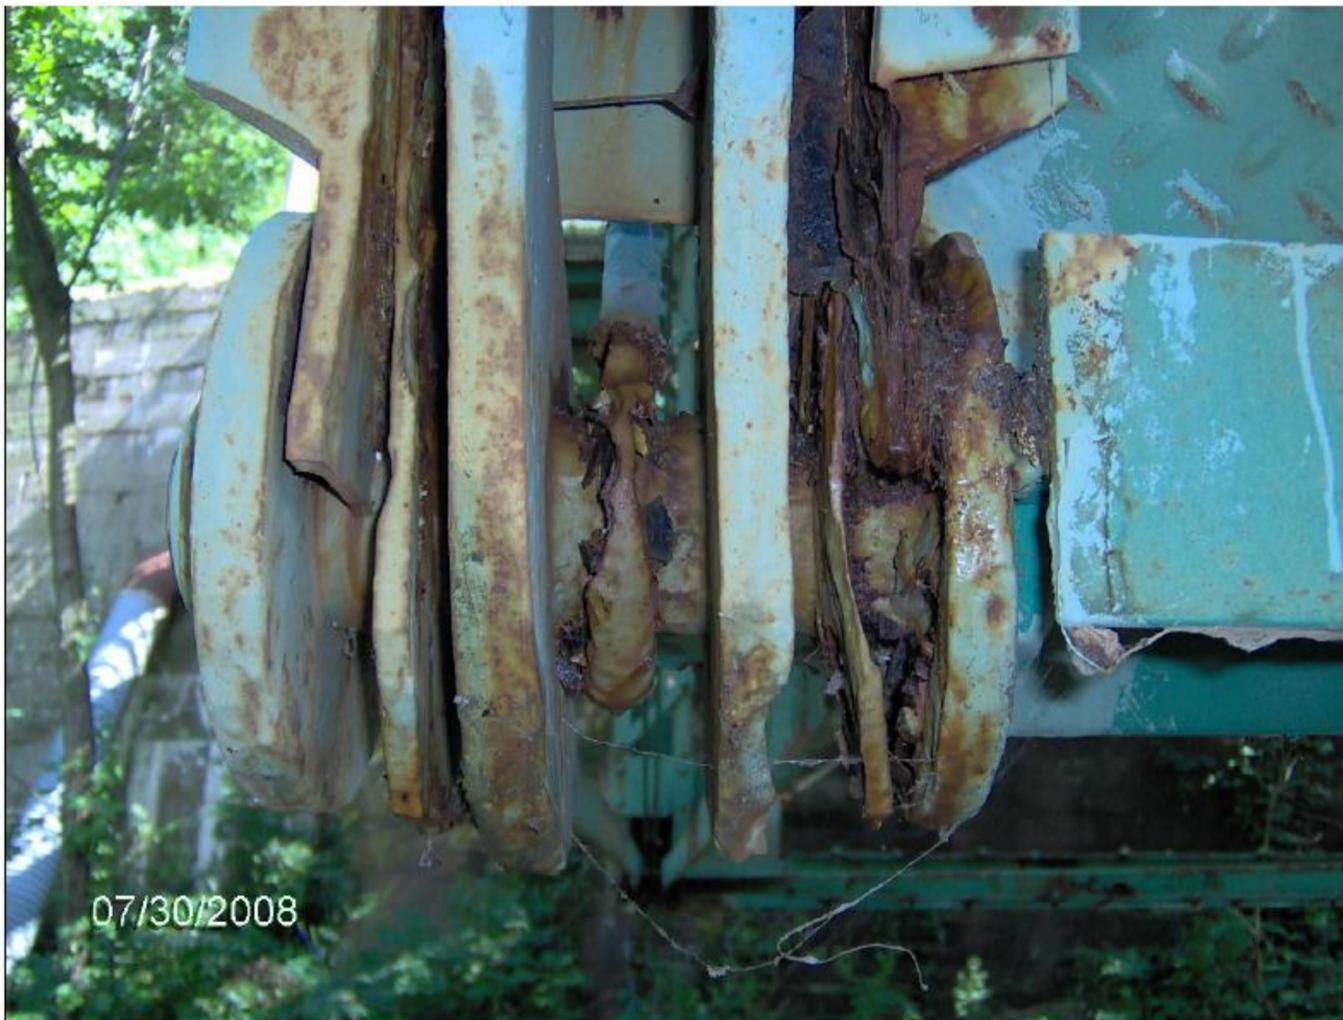
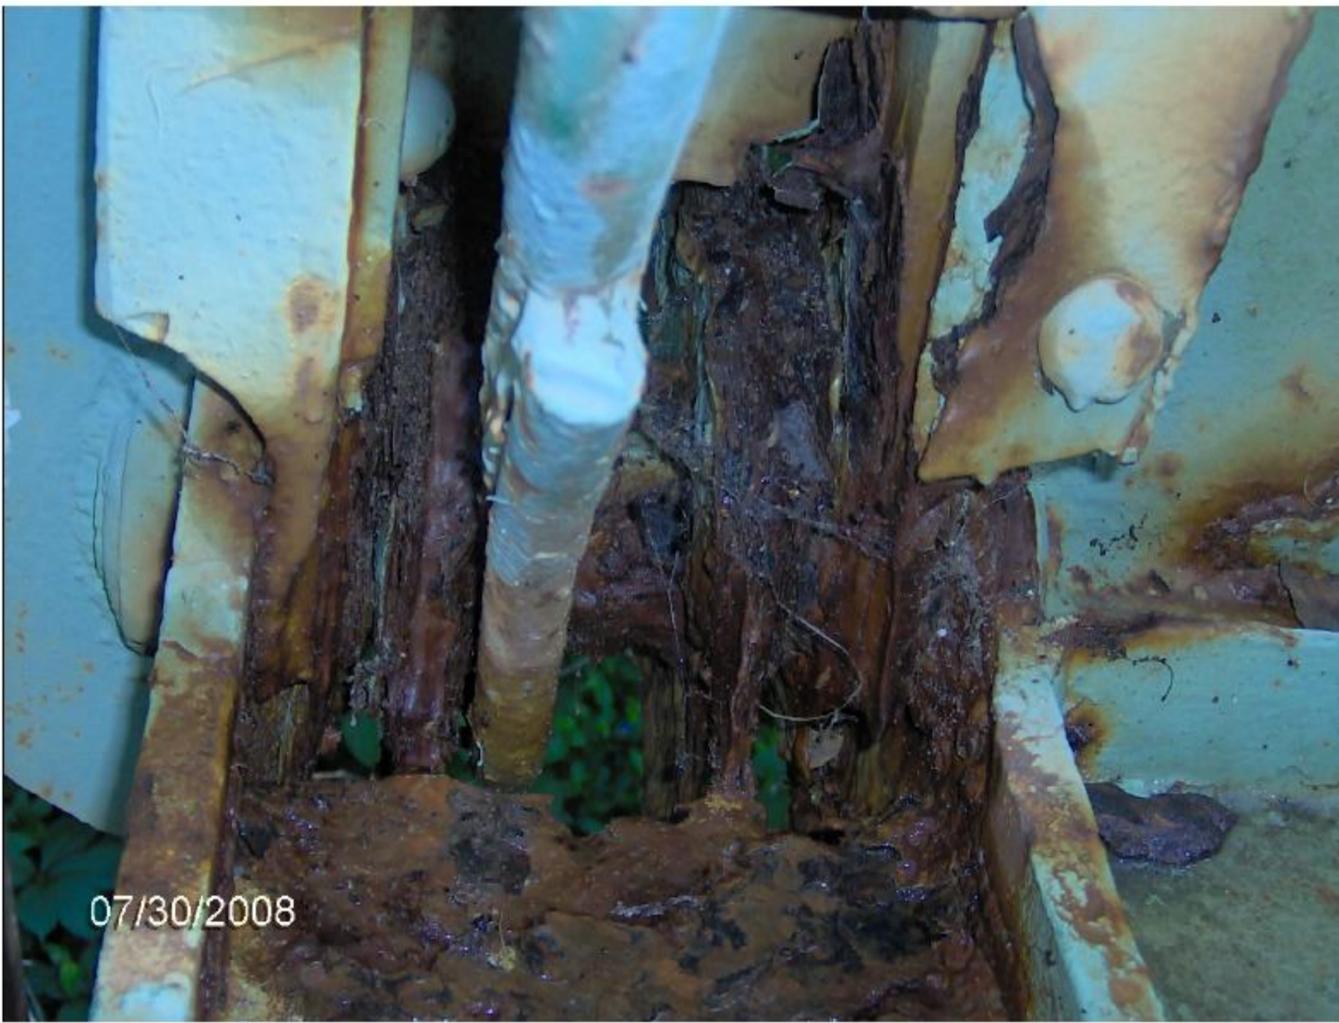
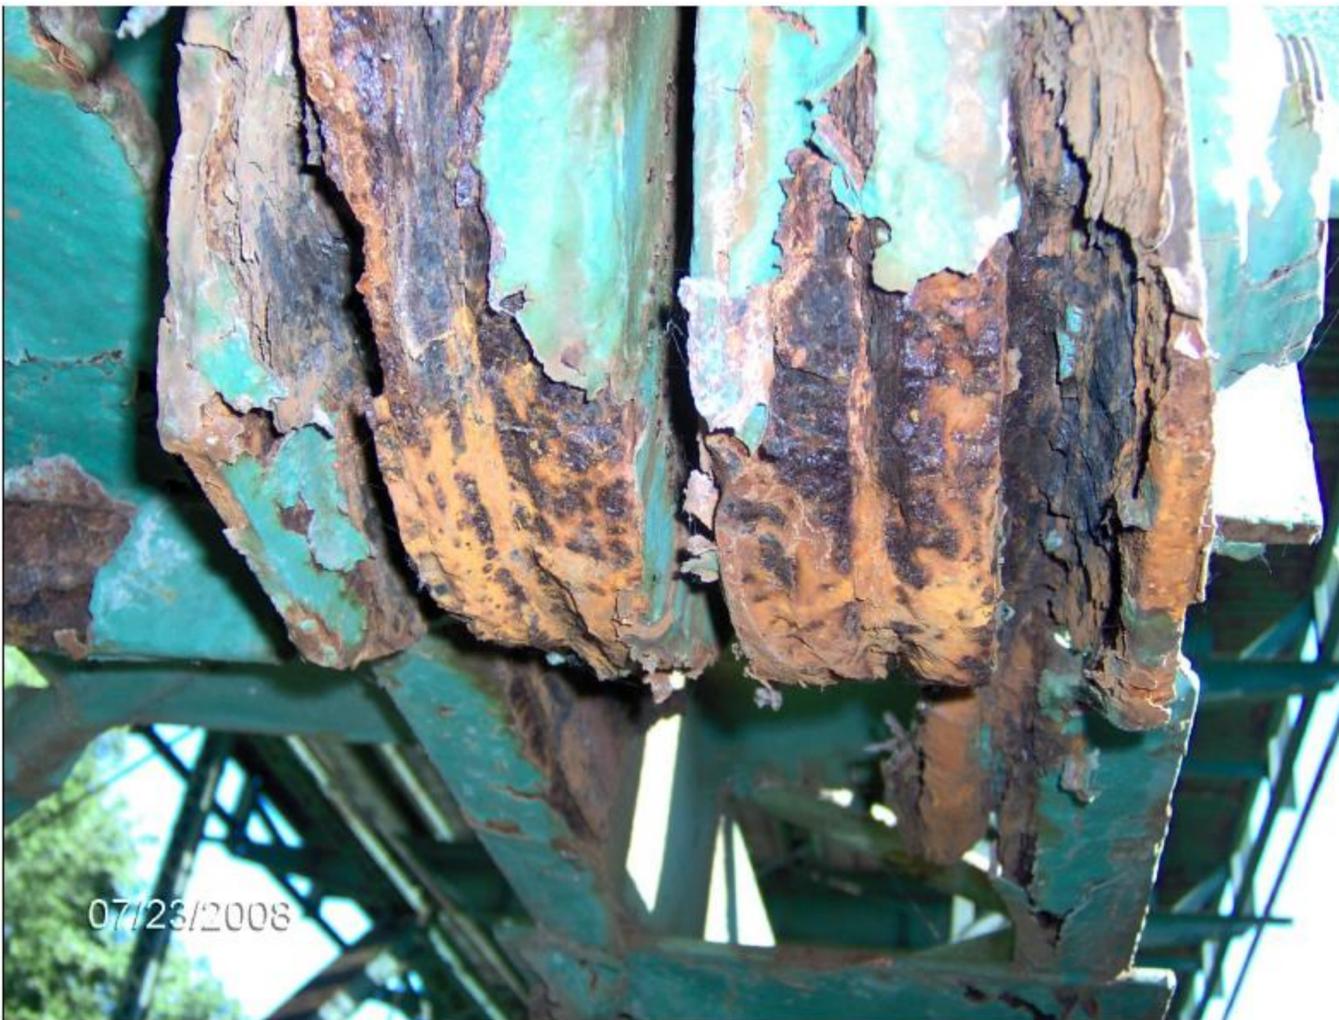
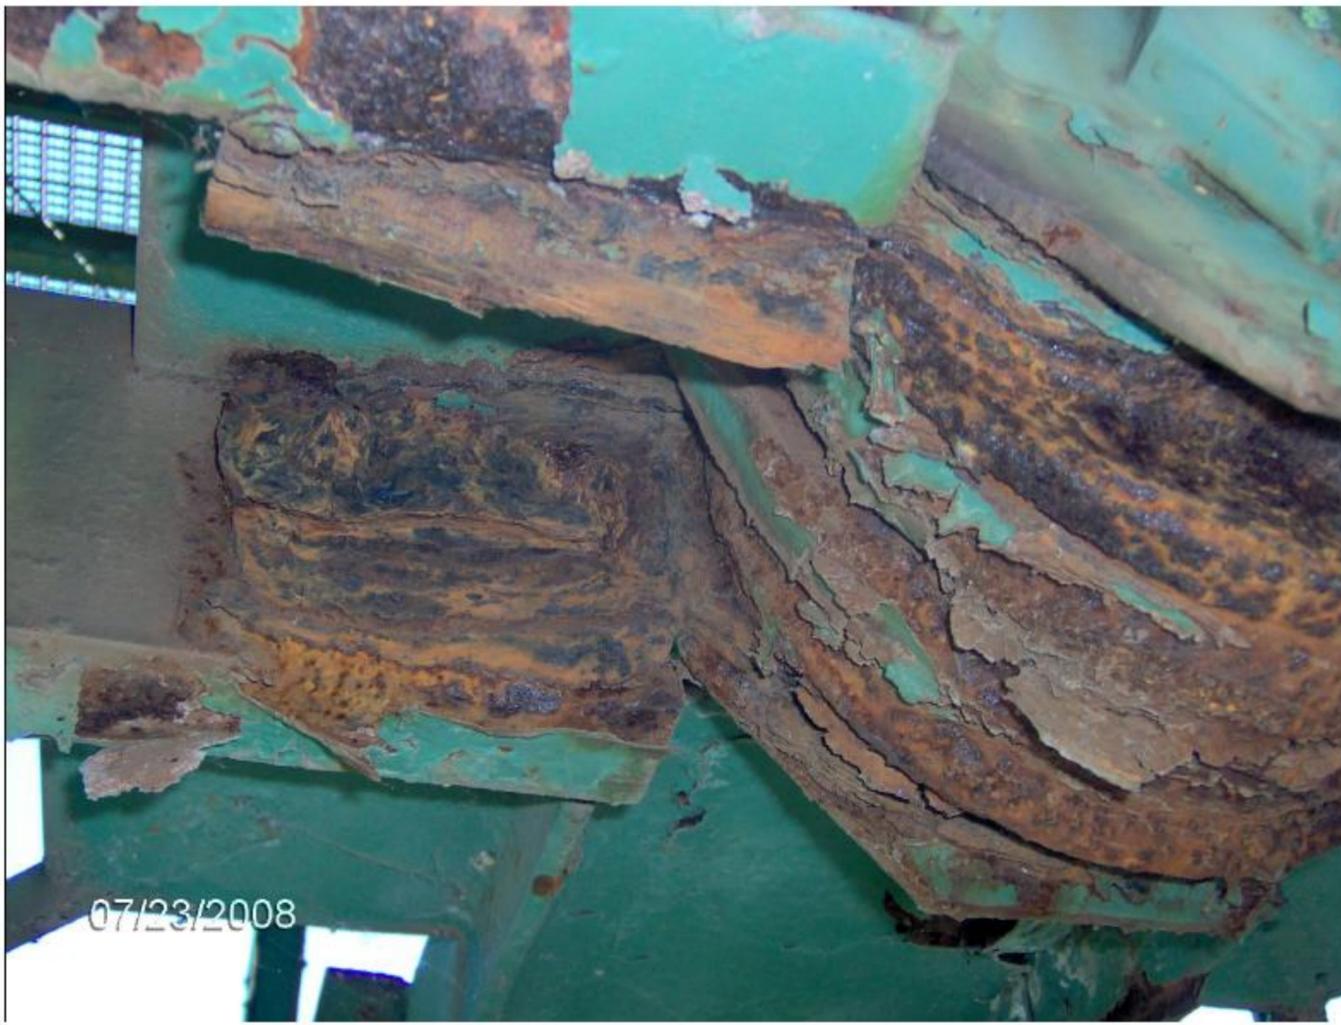
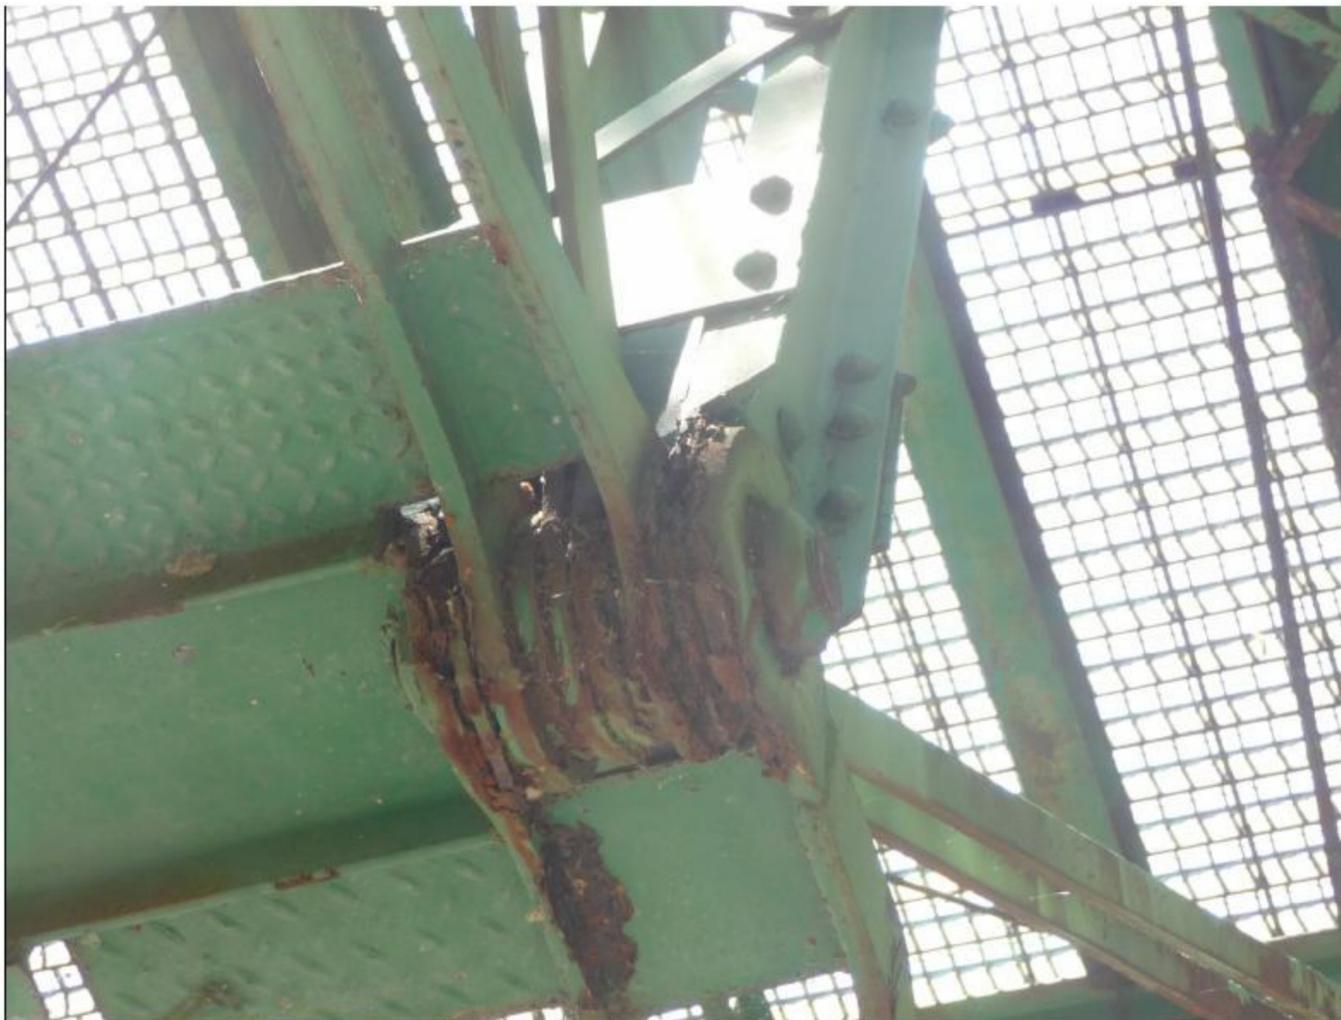
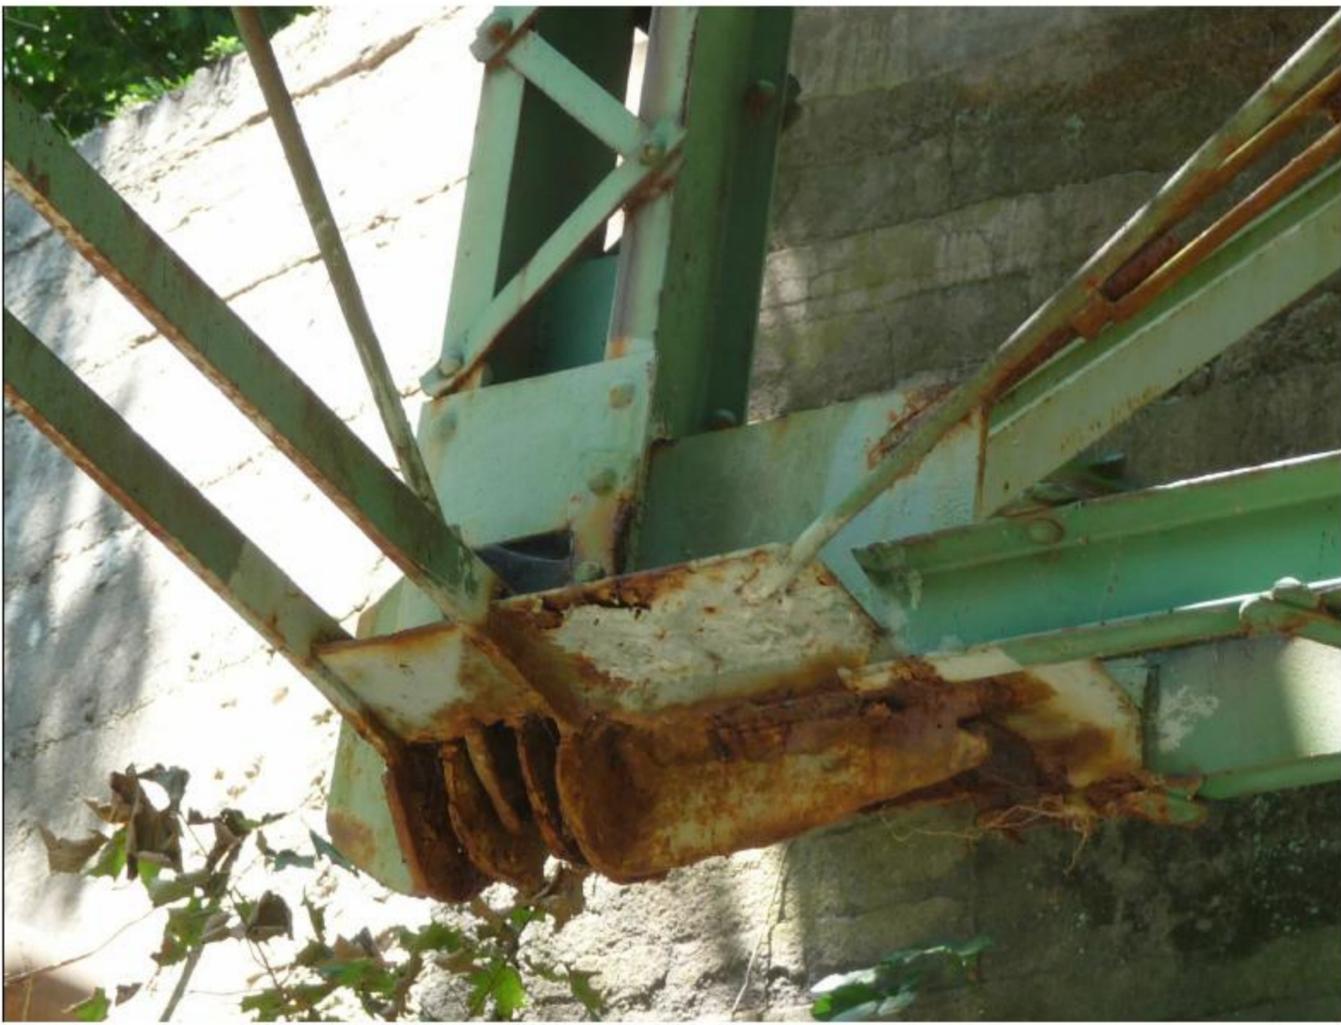
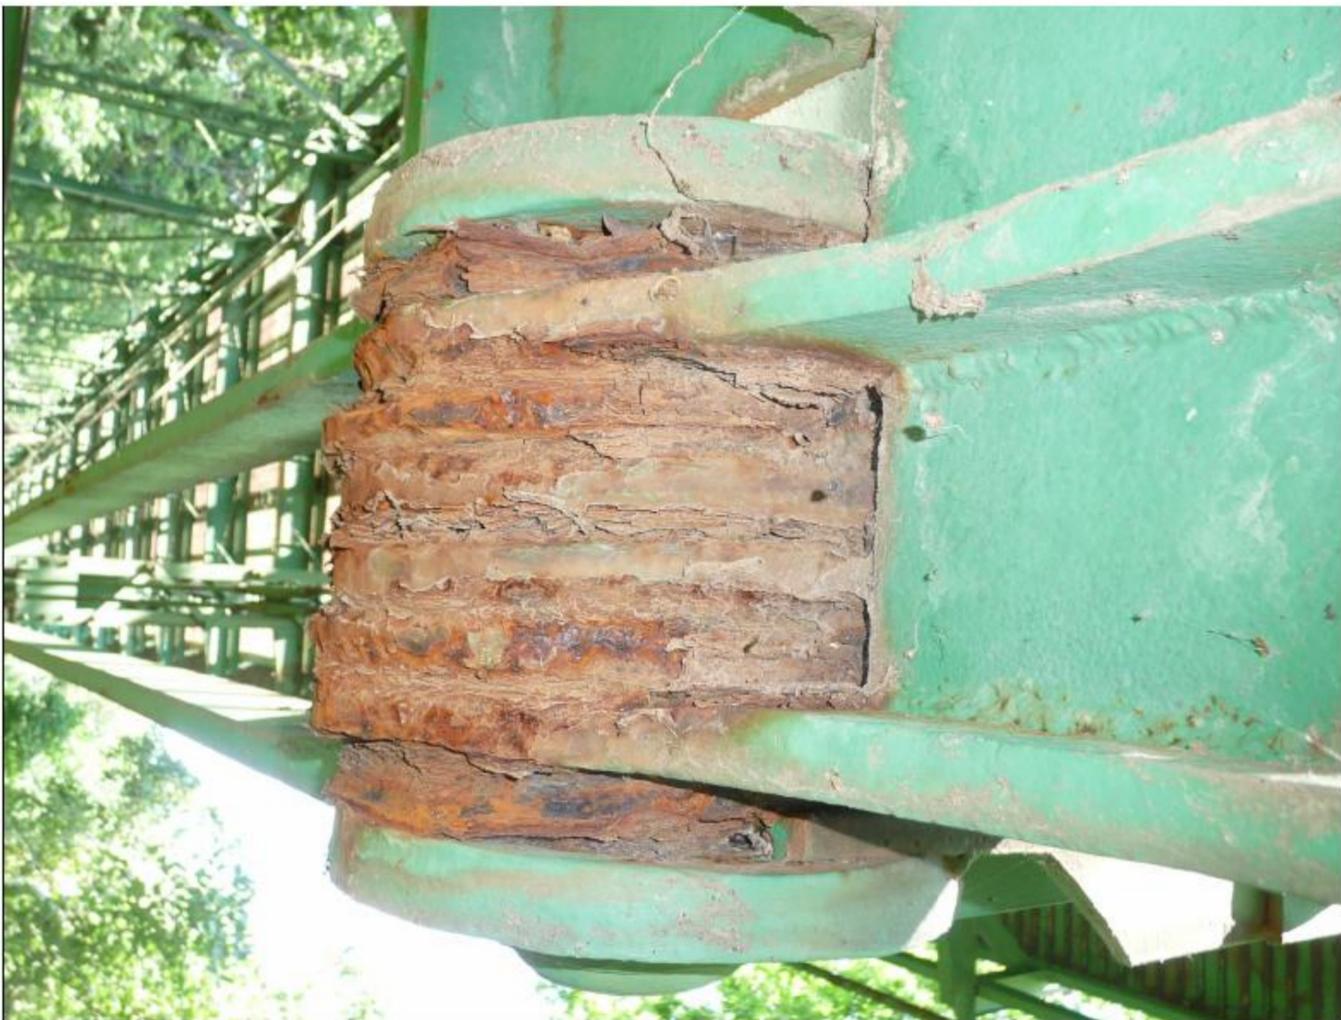
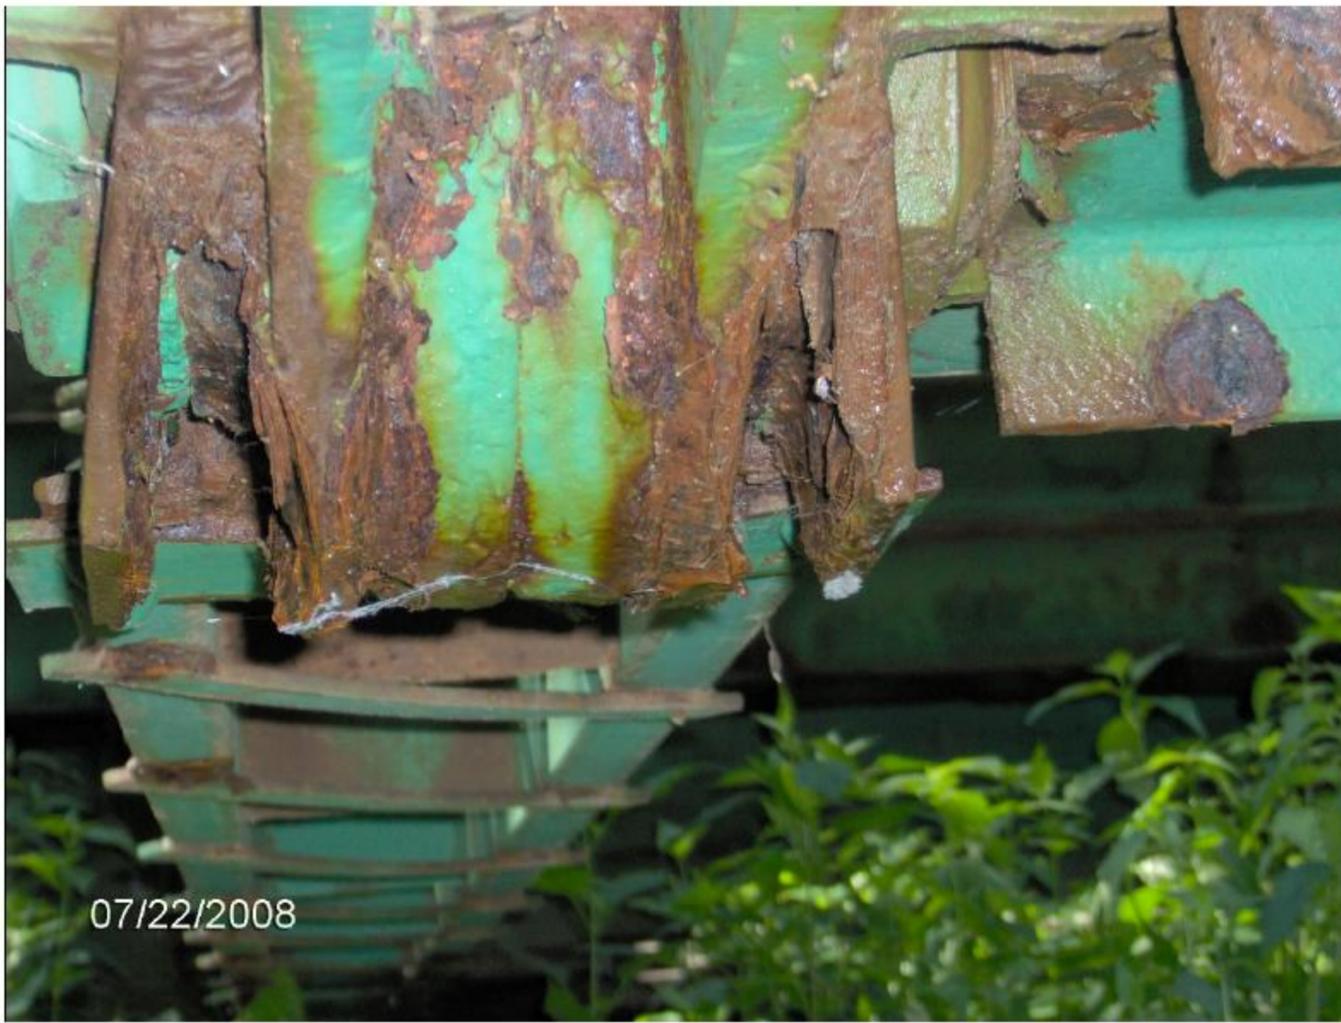
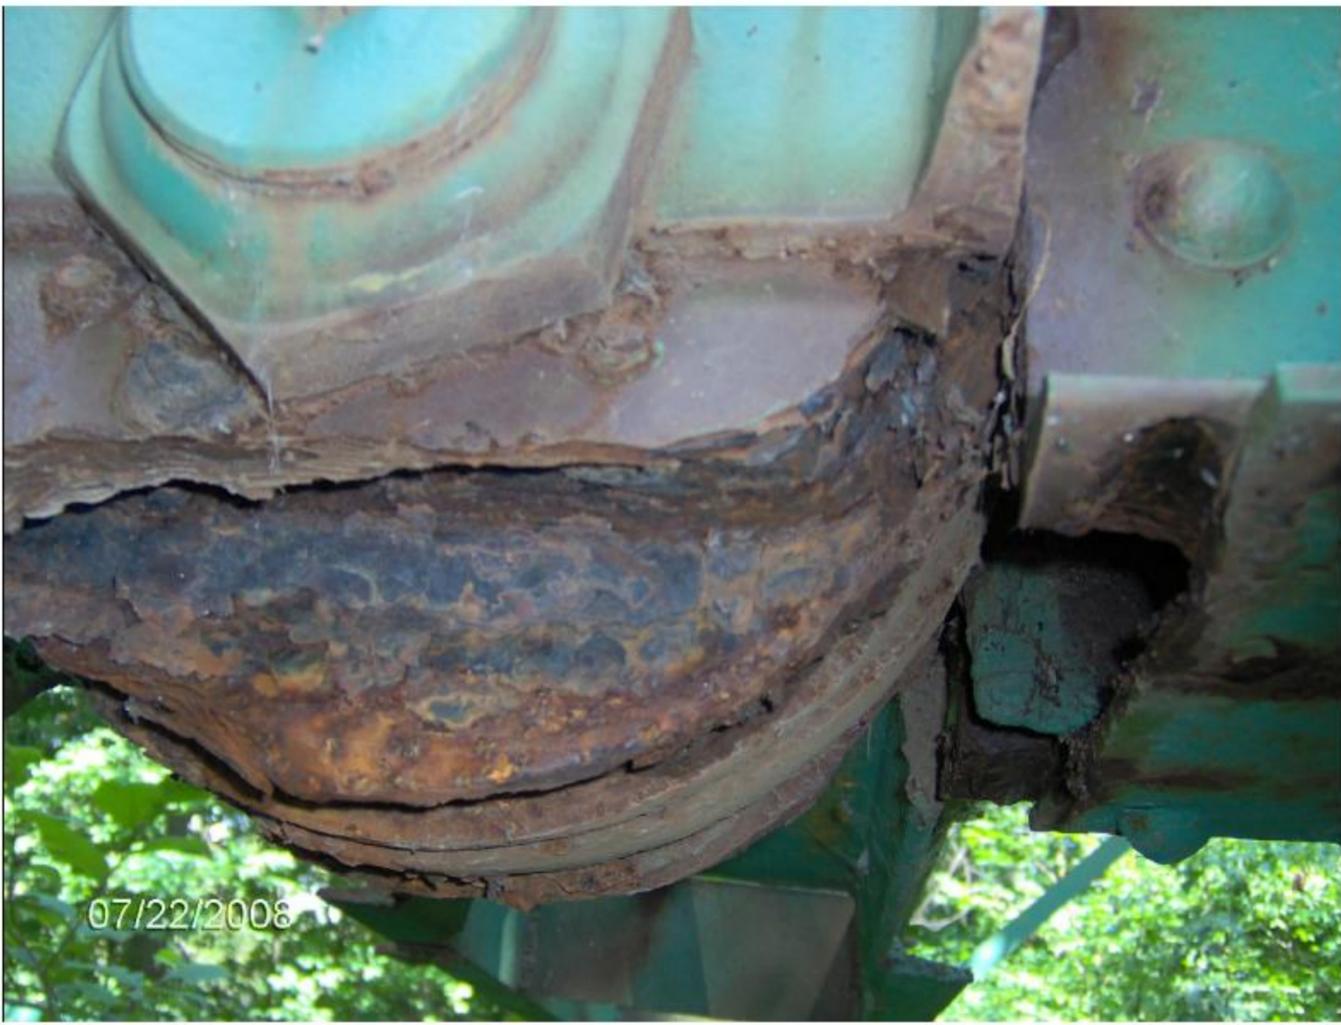
Eyebar ends exhibit severe section loss and deterioration at panel points. In addition, the eyebar “slack” observed indicates that tension load is not equally shared in eyebar sets. The “slack” could be caused by original manufacturing practices or by localized eyebar deterioration at the pin connections.

Based on the high levels of deterioration and corrosion at panel points, the inaccessibility of eyebar and rod ends for inspection and monitoring to ensure public safety, and the high stresses common to all eyebar ends, in addition to the low allowable stress of the eyebars, we recommend that all eyebars and rods be replaced with similar elements using modern materials.

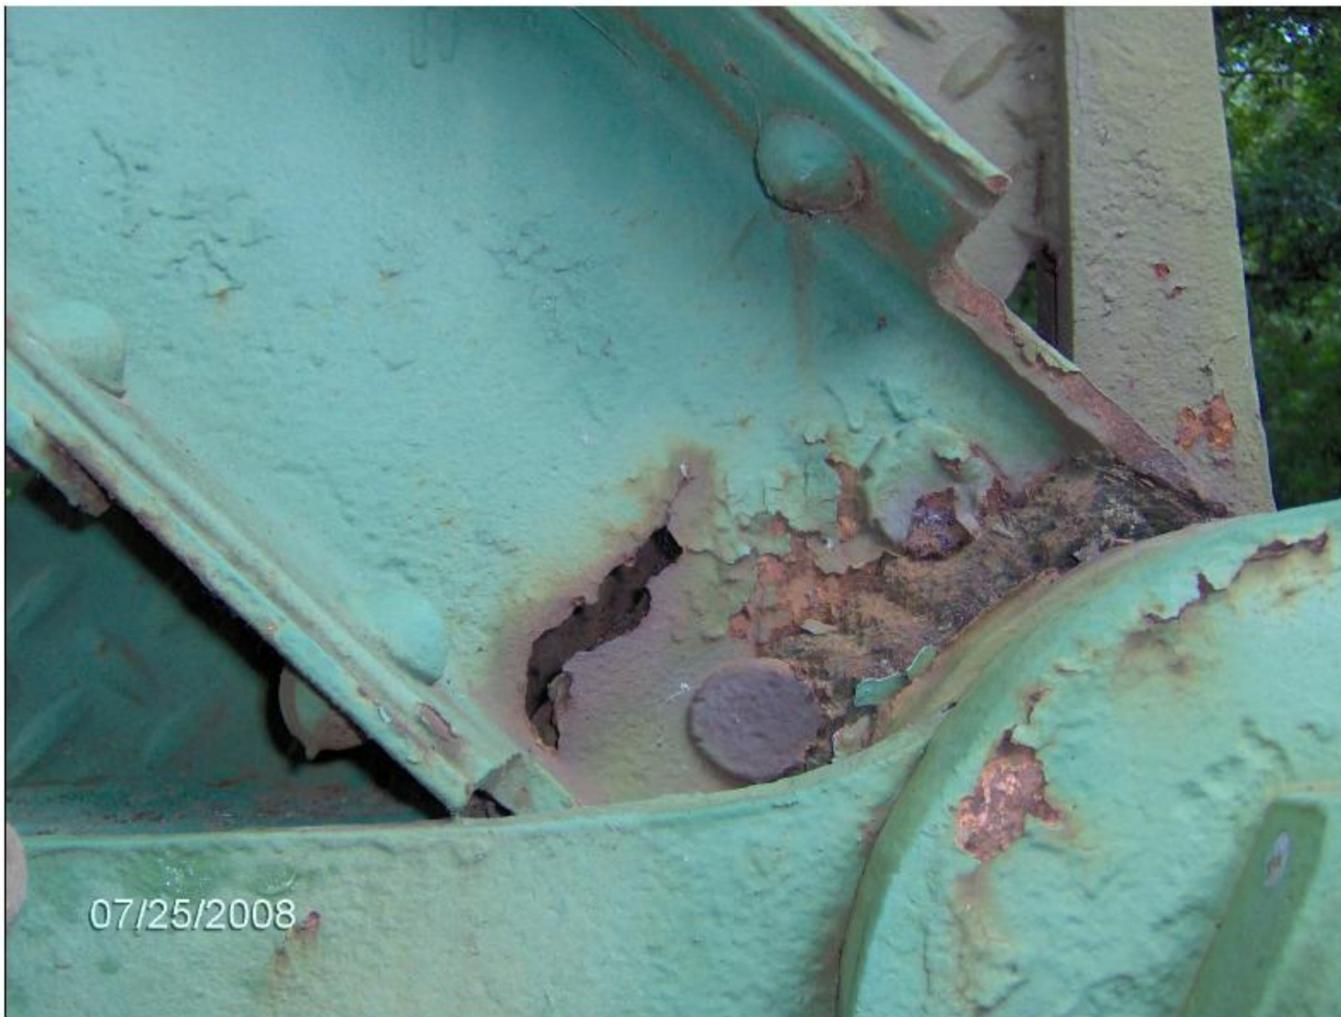
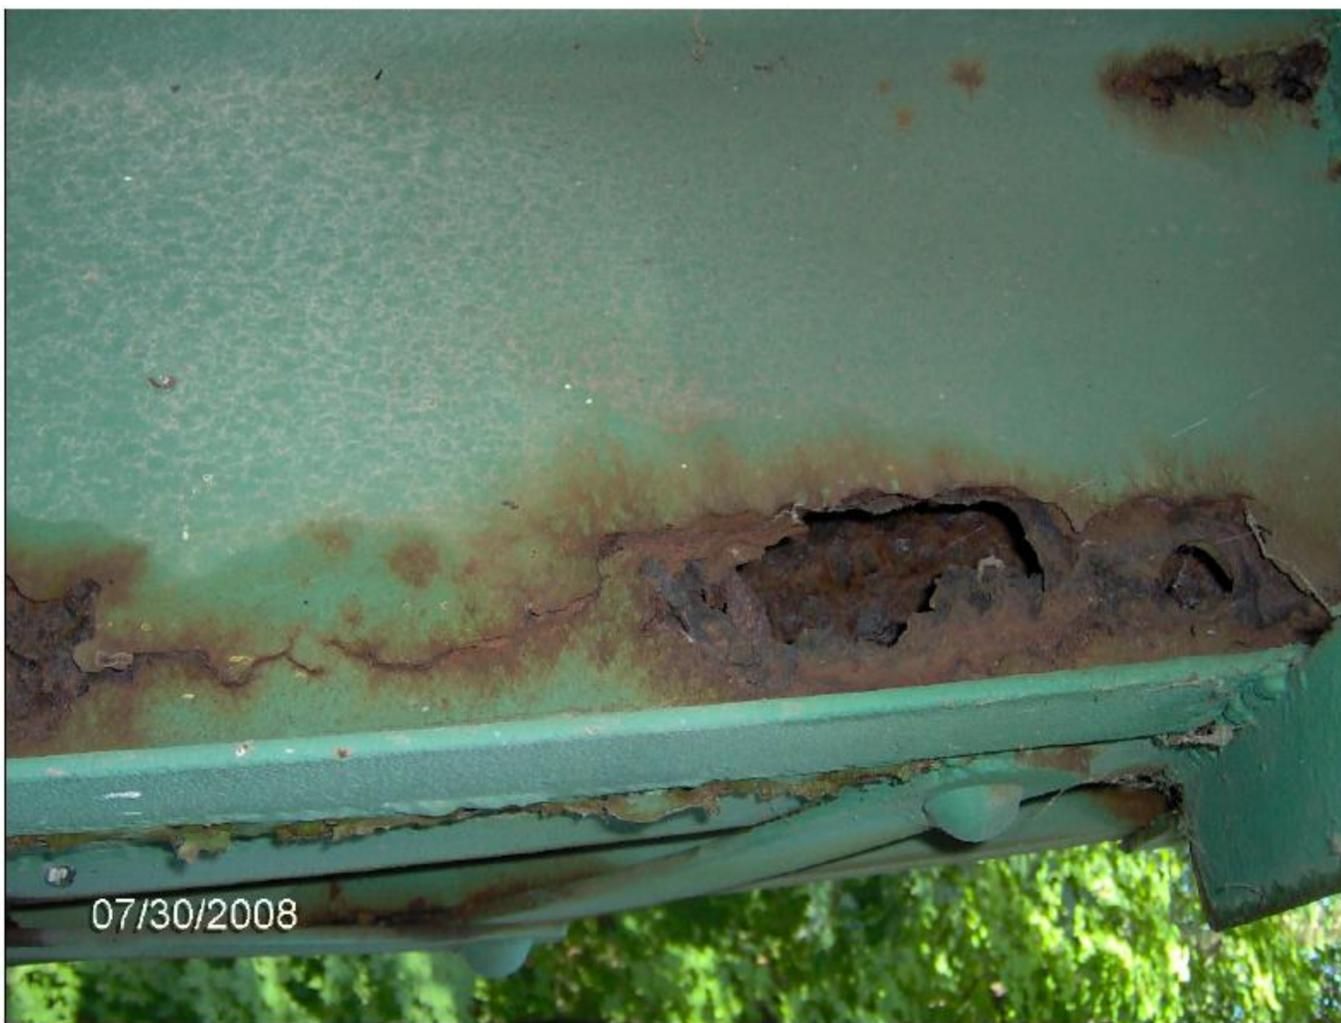
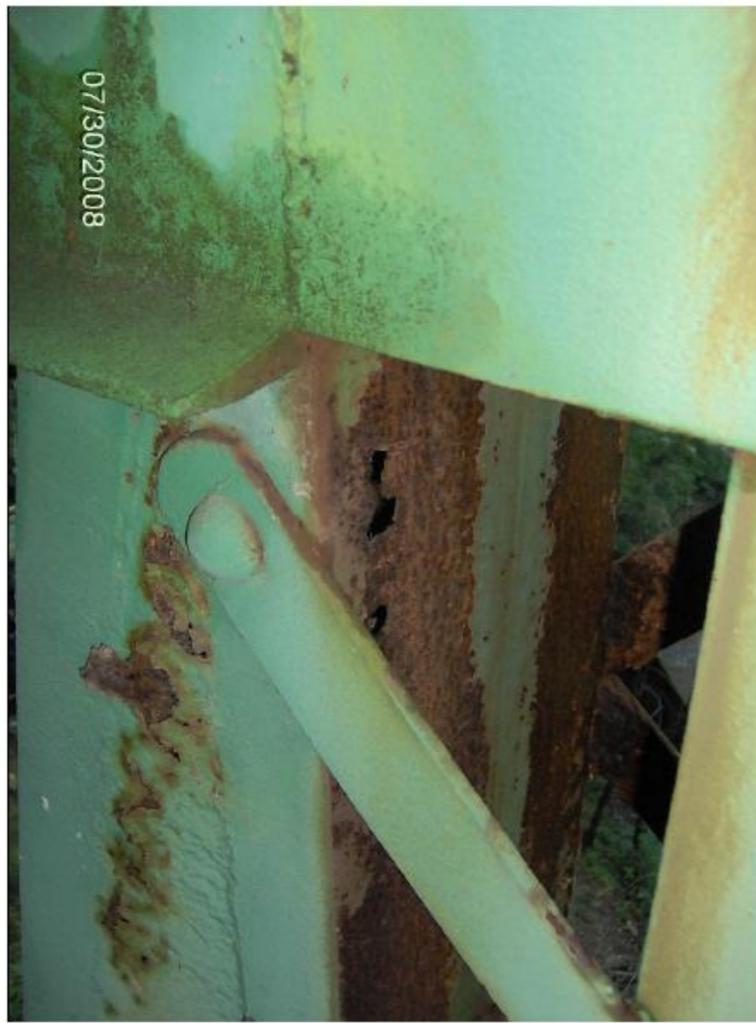
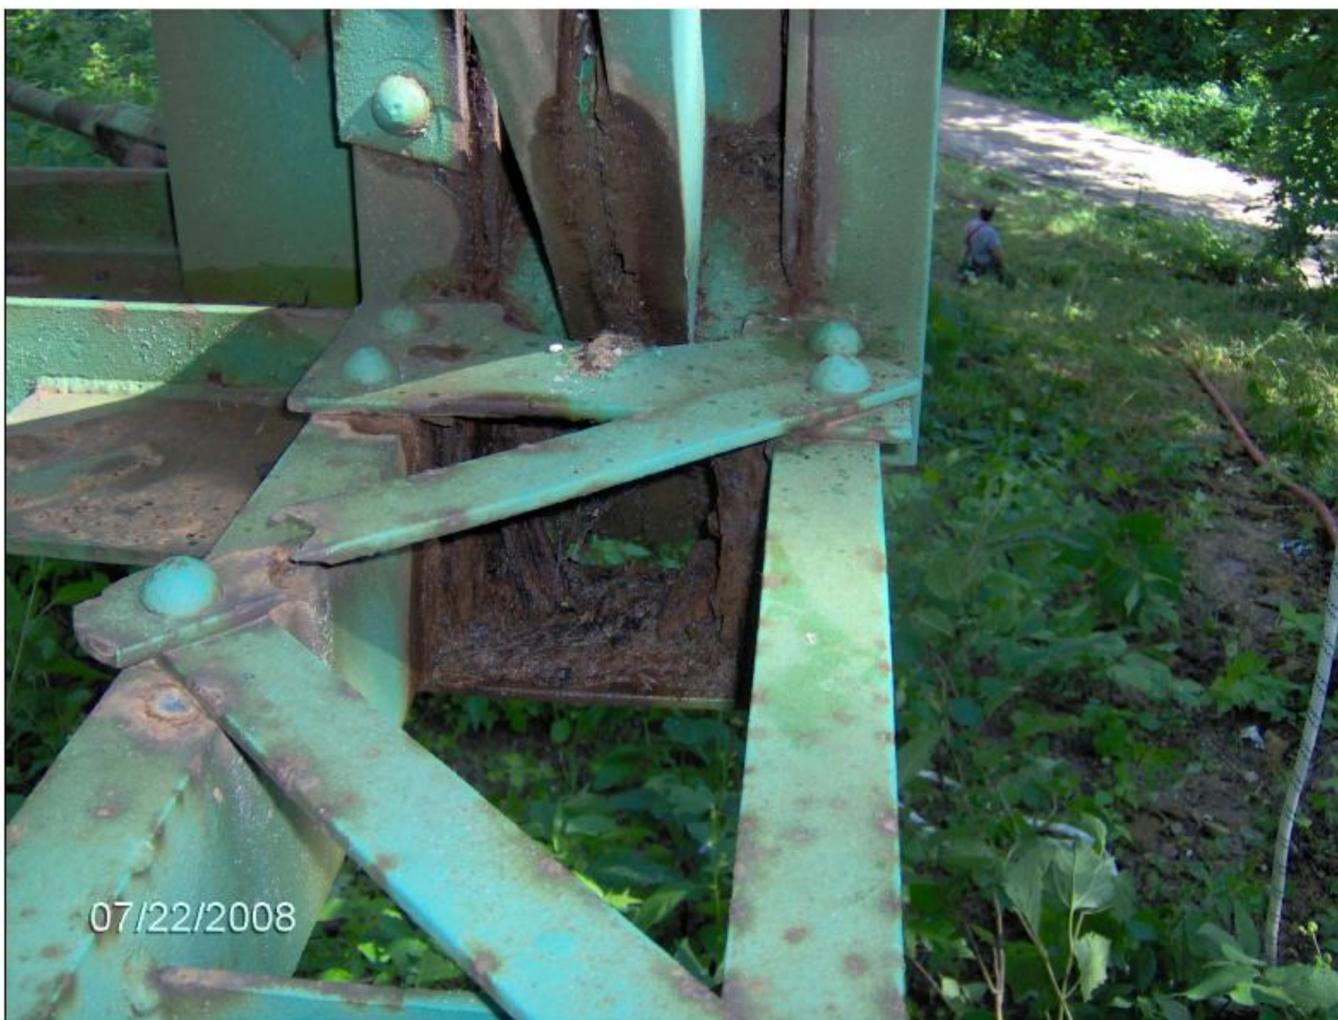
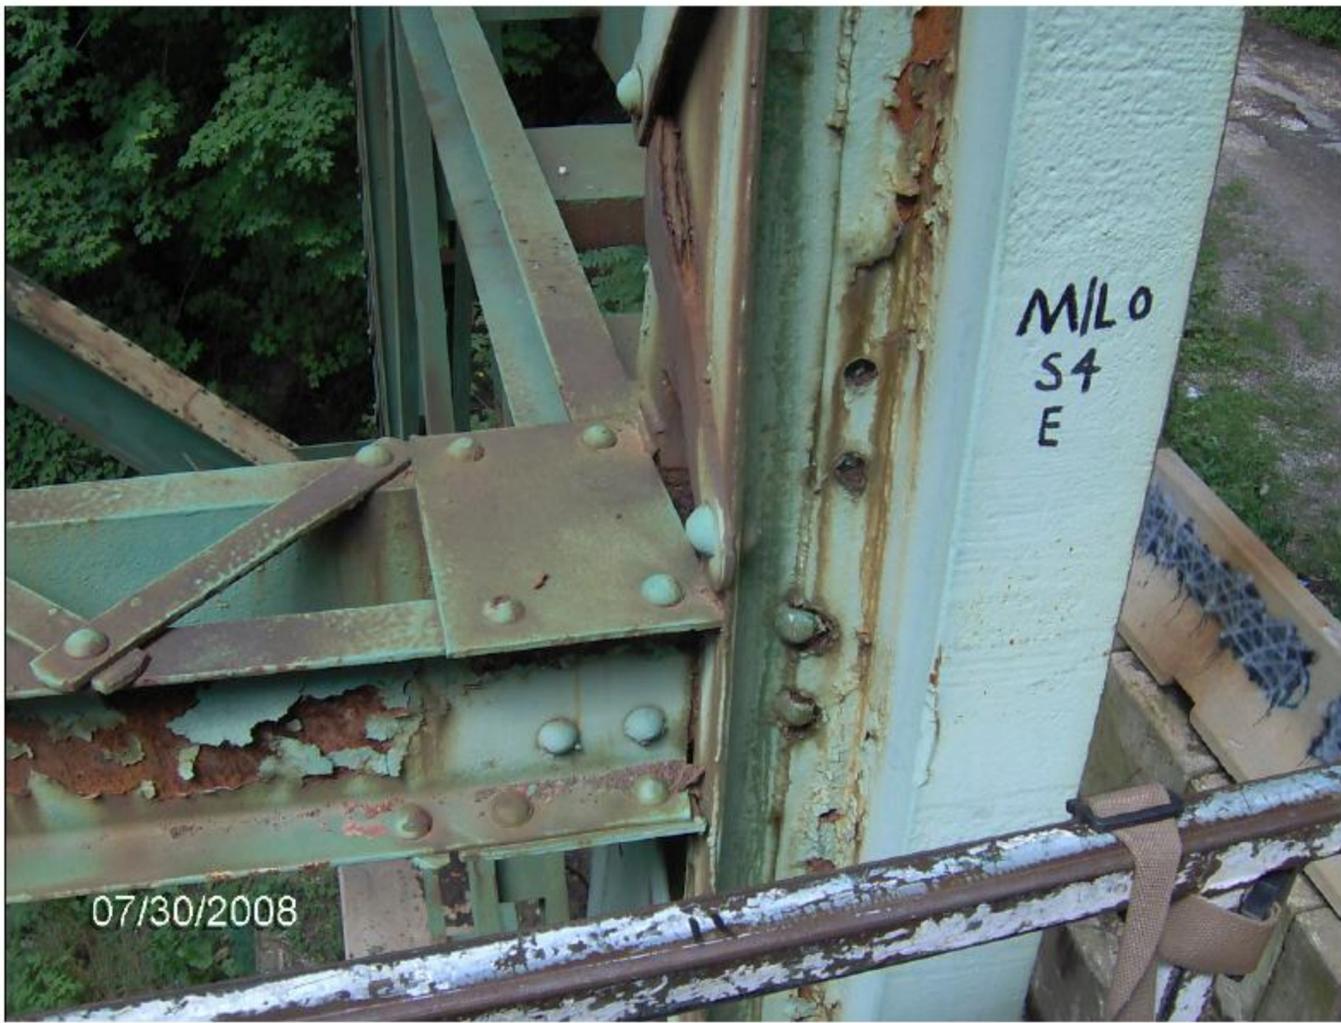
Previous inspection reports indicate several deficiencies relating to the truss compression members. Severe section loss is noted in several areas, with complete section loss of portions of members in some locations (**see Photos E3.1 thru E3.3**). Many compression members have broken or missing lacing elements (**see Photo E3.4**). In addition, many rivets are missing from the built-up members (**see Photo E3.5**). Poor welds are reported from previous rehabilitations. Many built-up members exhibit pack rust accumulation between member elements, causing local distortions (**see Photos E3.6 thru E3.10**).

Members exhibiting severe section loss should be repaired or replaced. Damaged lacing should be repaired, and missing rivets should be replaced with equivalent size high tensile strength bolts. It was previously noted that pack rust has accumulated between member elements and caused local distortion. There is no simple method to repair this damage. The deformations are similar to local buckling initiated under high member stress; the deformations can reduce the member capacity by an amount that is not readily quantified.
