# Cascade Bridge Rehabilitation Evaluation

PREPARED FOR  
CITY OF BURLINGTON  
DEPARTMENT OF PUBLIC WORKS

SEPTEMBER 2012

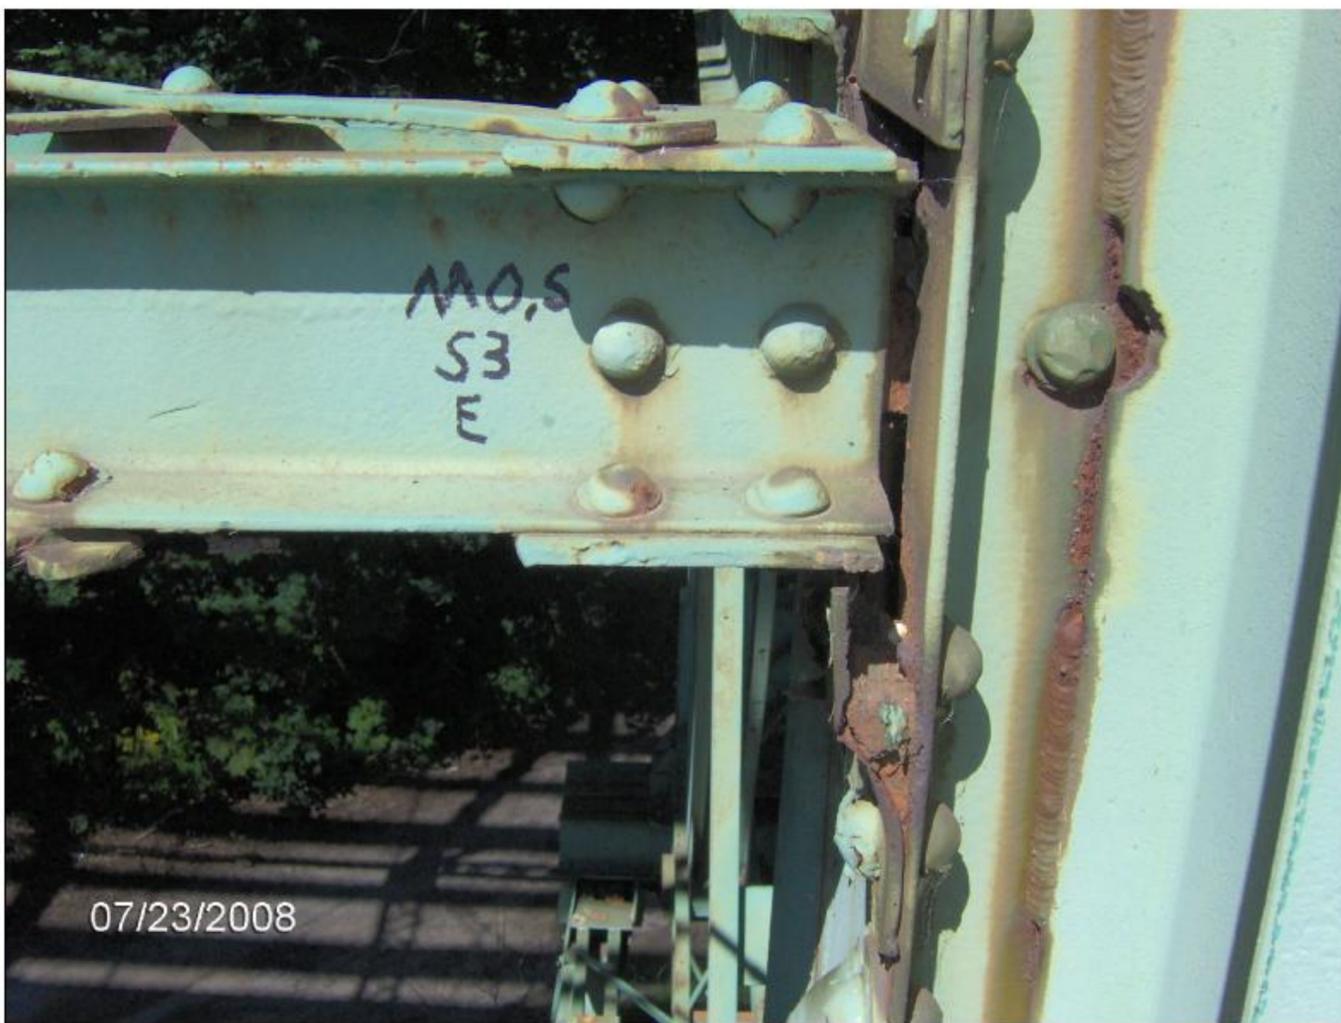
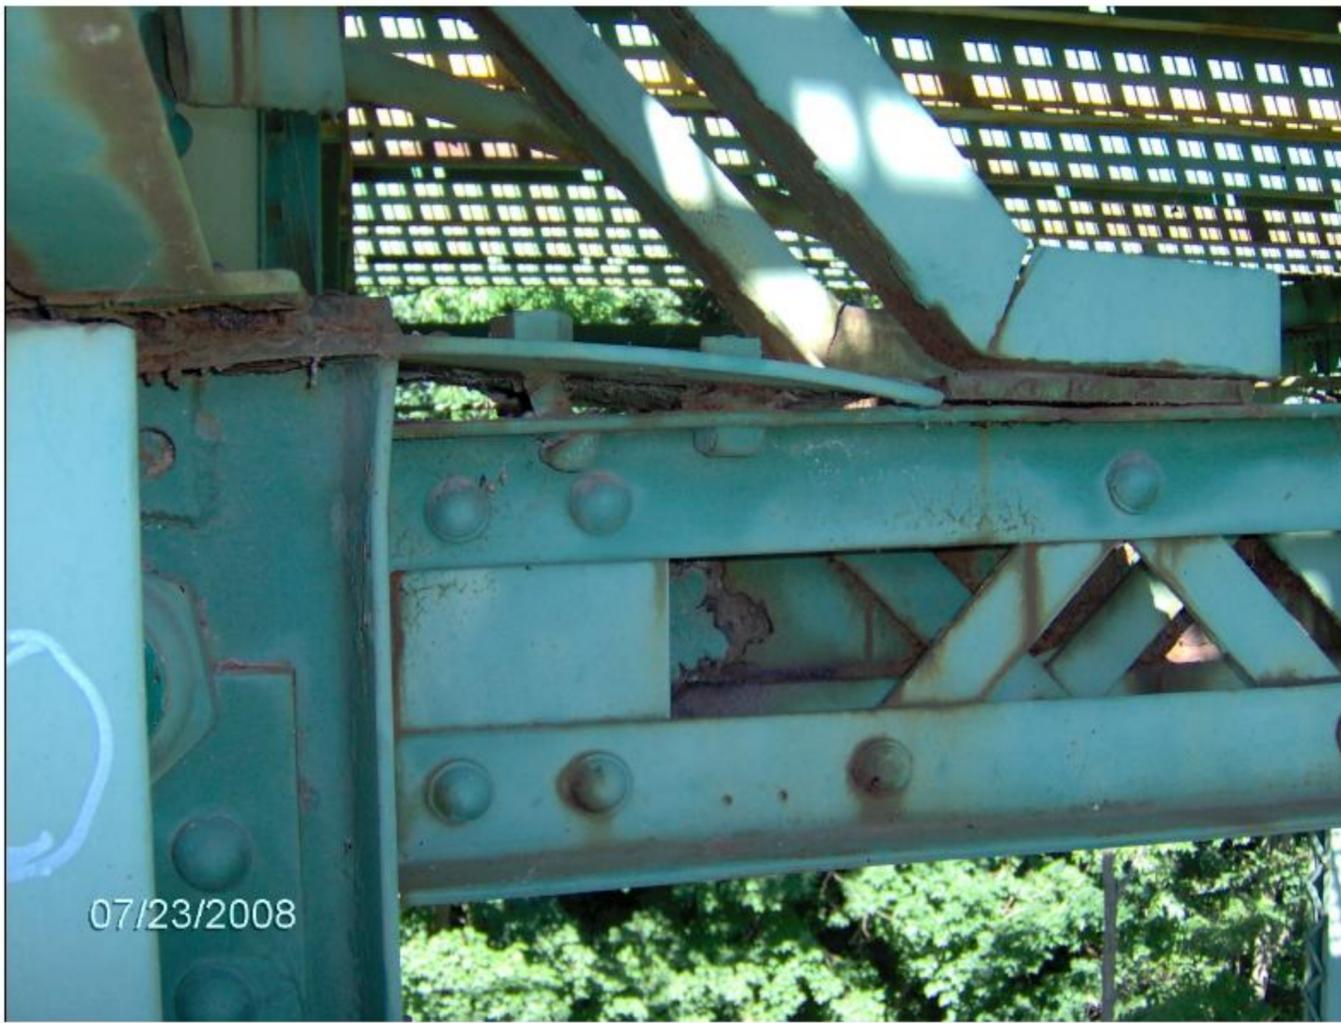
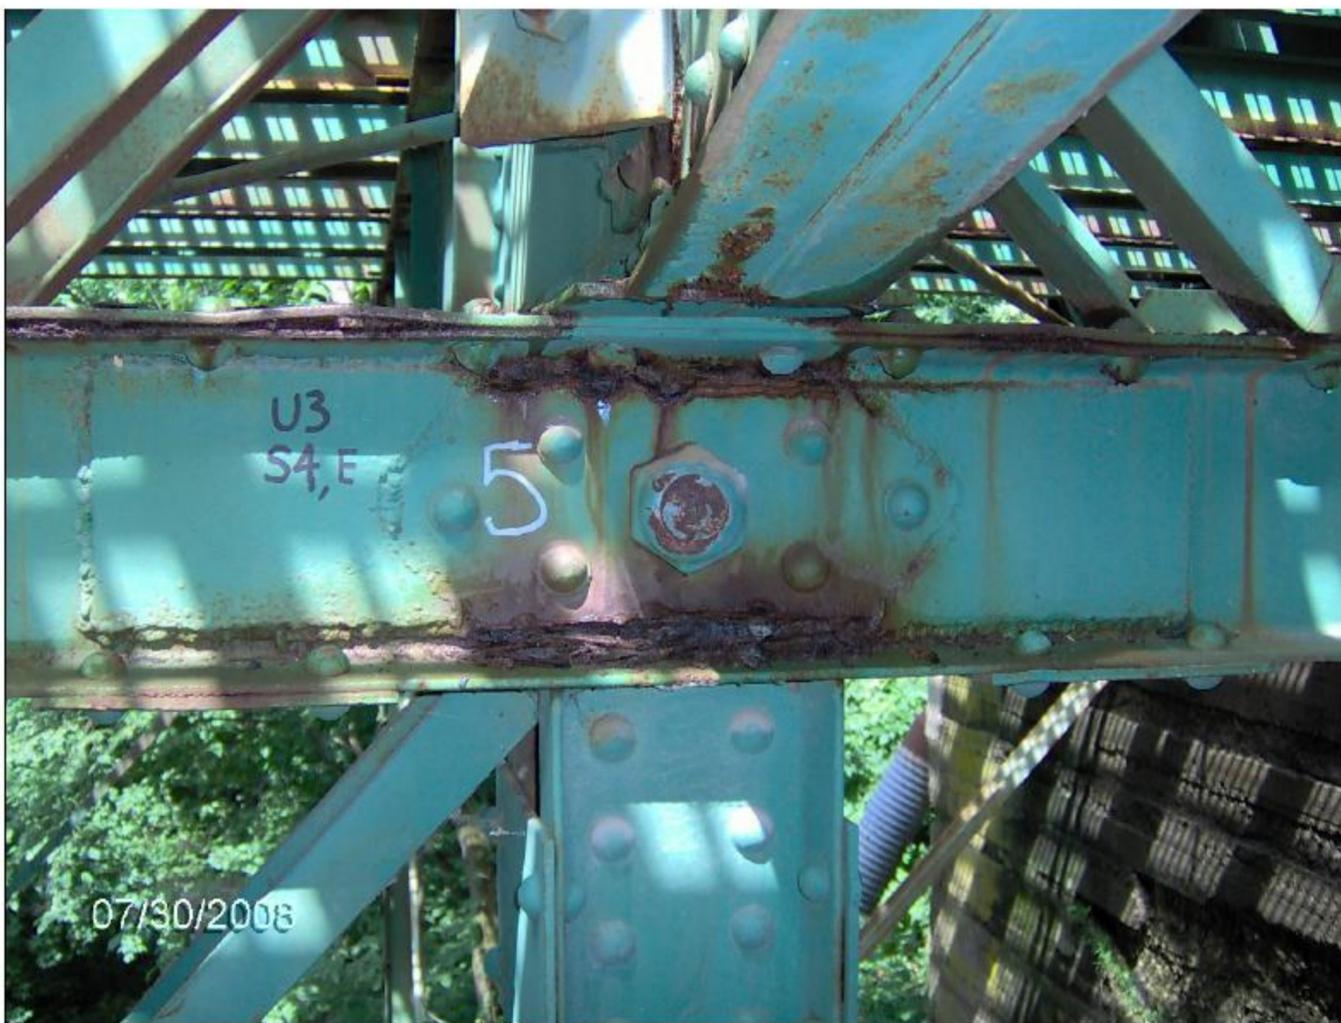
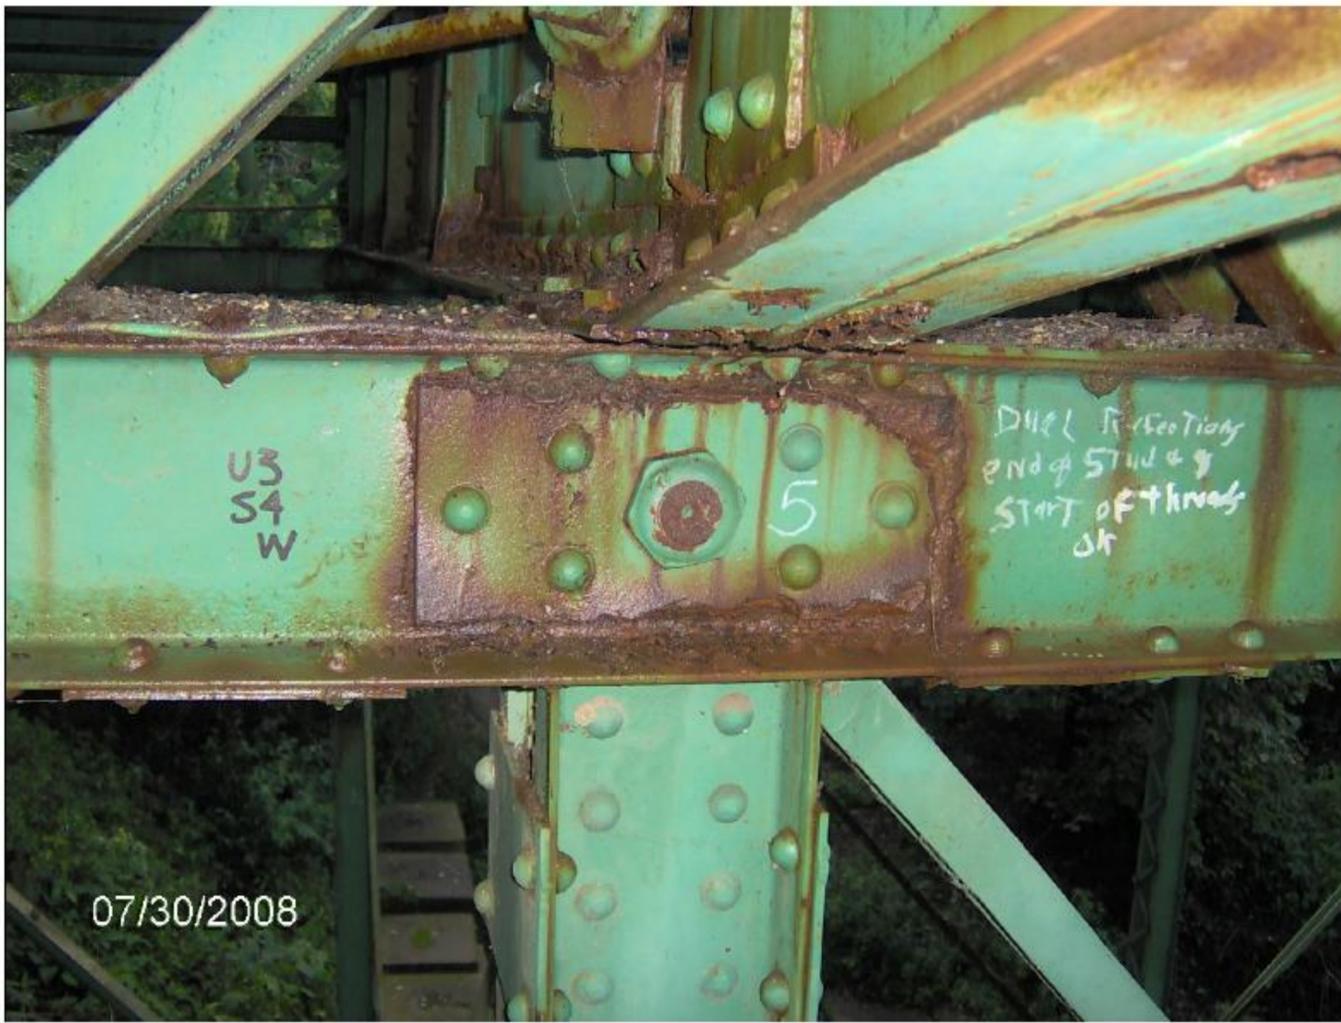
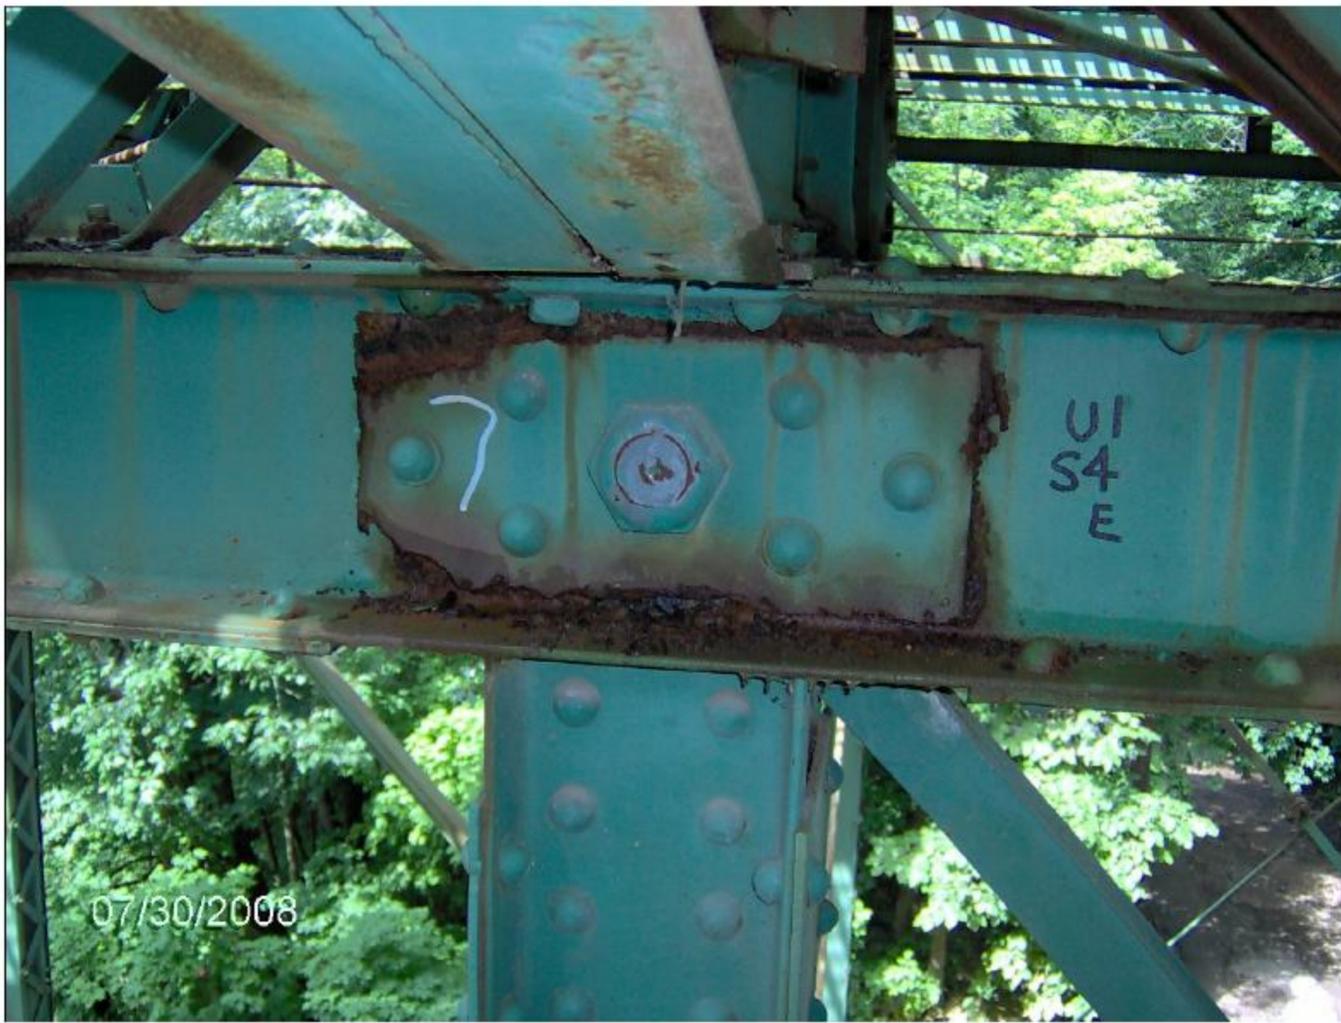
Previous inspection reports indicate several deficiencies relating to the truss compression members. Severe section loss is noted in several areas, with complete section loss of portions of members in some locations (**see Photos E3.1 thru E3.3**). Many compression members have broken or missing lacing elements (**see Photo E3.4**). In addition, many rivets are missing from the built-up members (**see Photo E3.5**). Poor welds are reported from previous rehabilitations. Many built-up members exhibit pack rust accumulation between member elements, causing local distortions (**see Photos E3.6 thru E3.10**).

Members exhibiting severe section loss should be repaired or replaced. Damaged lacing should be repaired, and missing rivets should be replaced with equivalent size high tensile strength bolts. It was previously noted that pack rust has accumulated between member elements and caused local distortion. There is no simple method to repair this damage. The deformations are similar to local buckling initiated under high member stress; the deformations can reduce the member capacity by an amount that is not readily quantified.

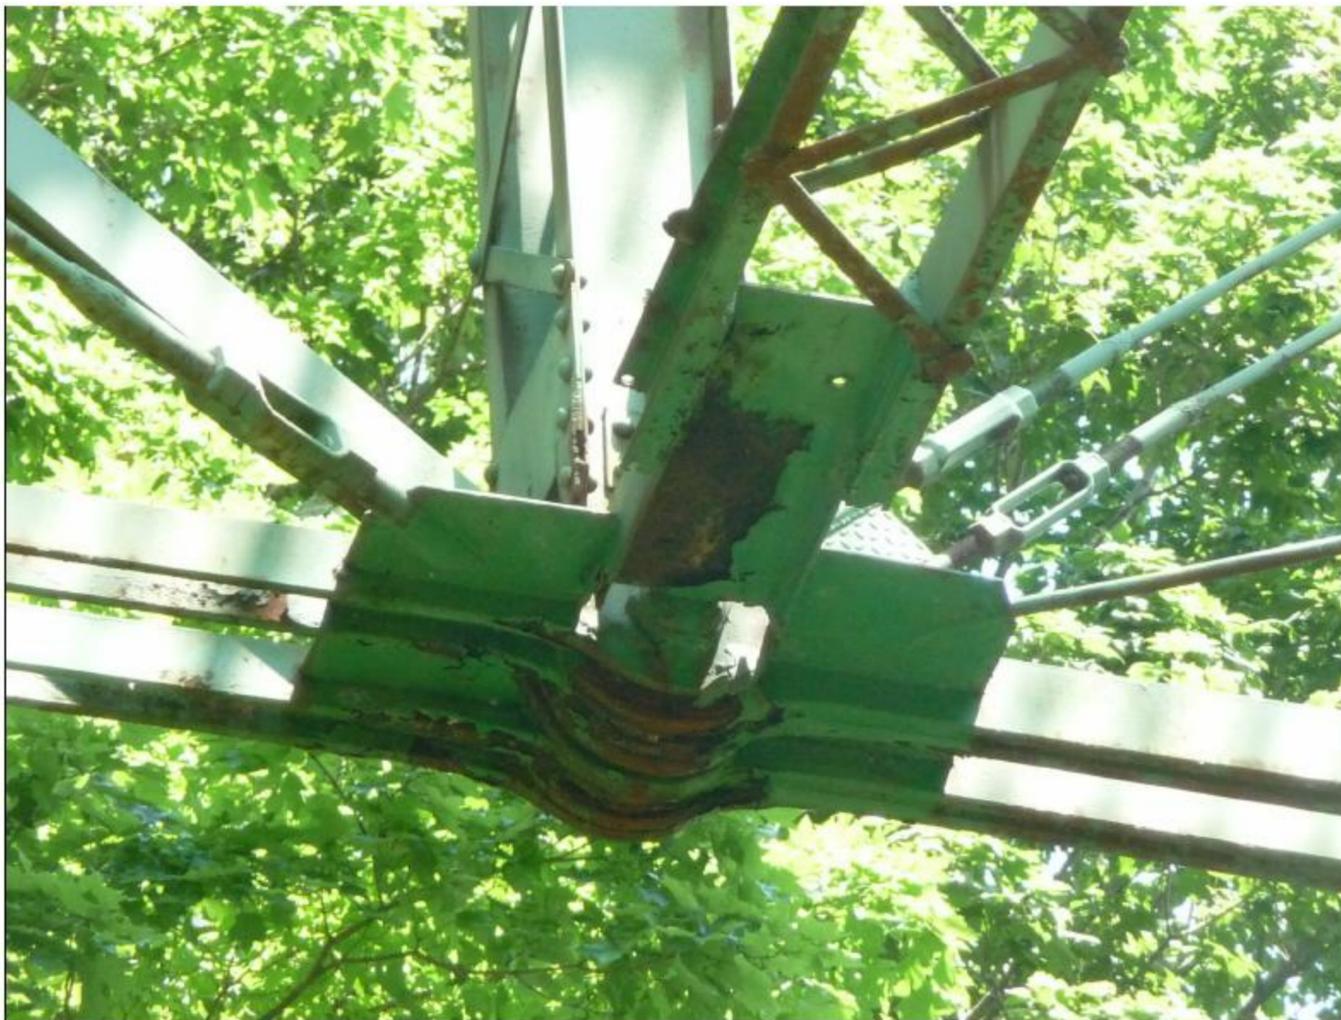
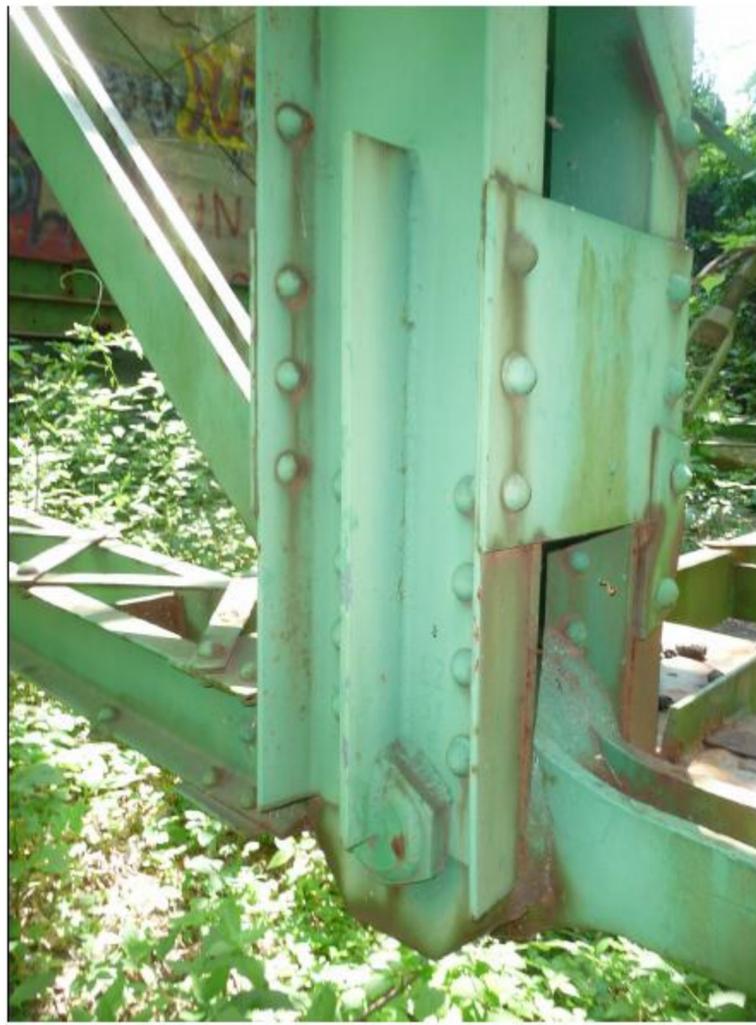
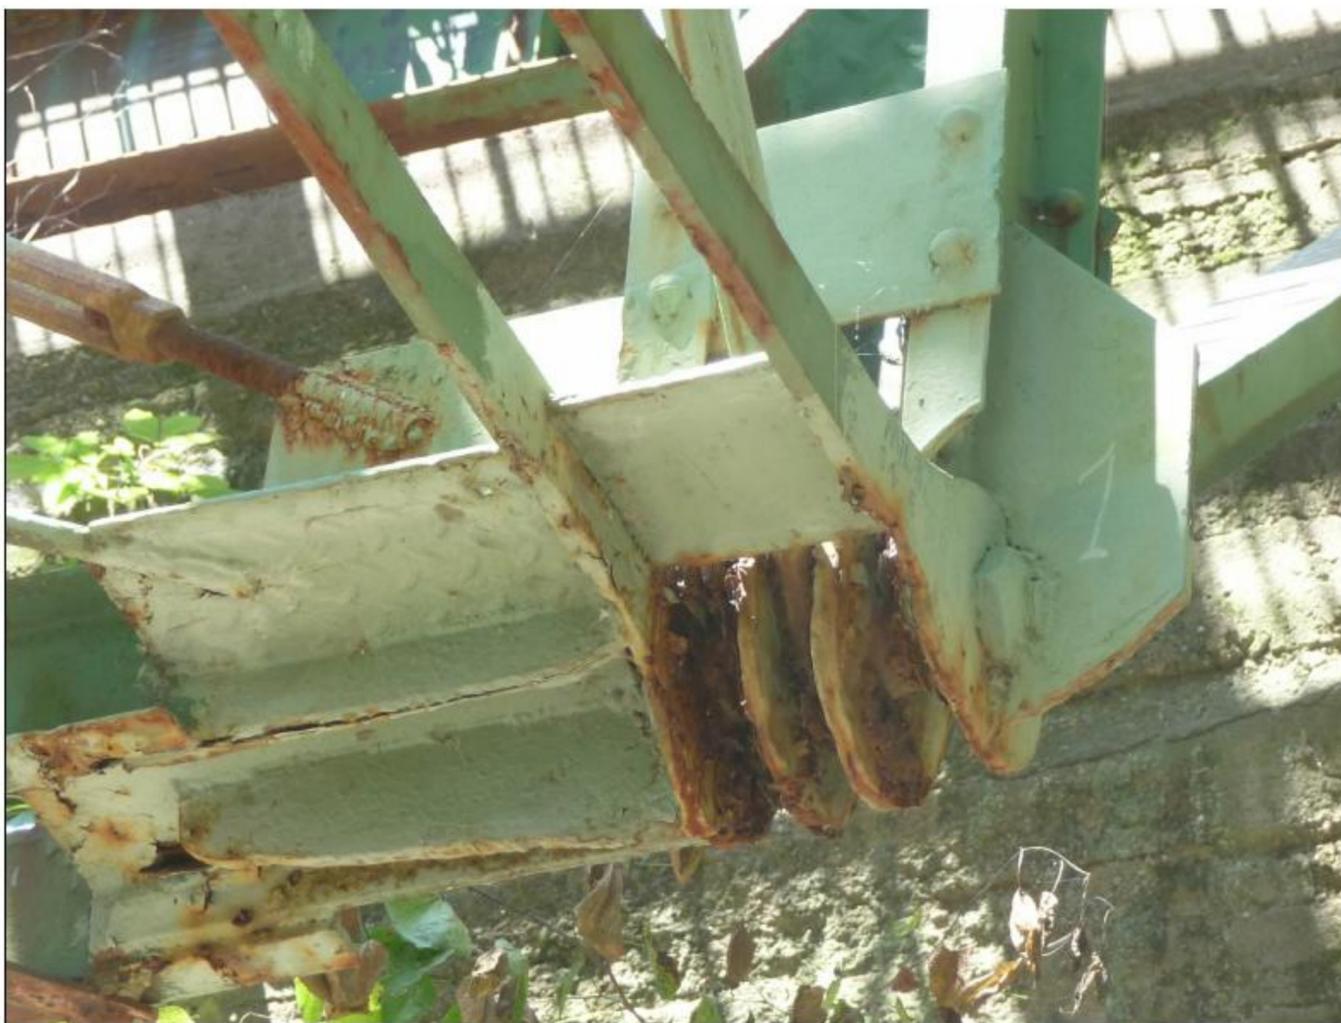
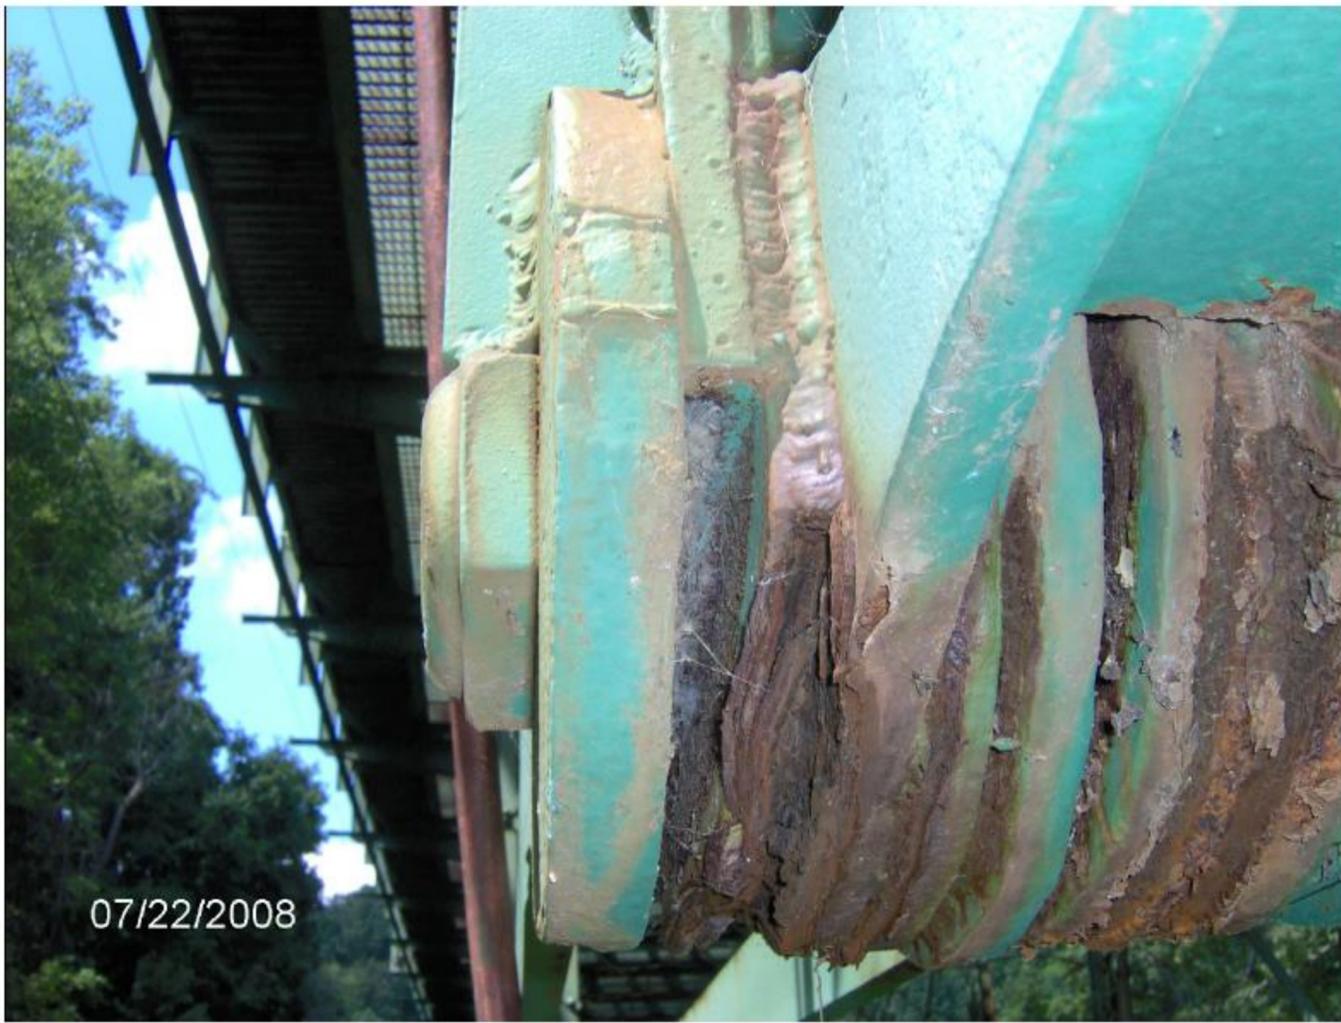
The 1953 and 1964/1978/1984 repair plans include details that were intended to provide reinforcing for eyebar ends and a method of fastening lateral and horizontal bracing members to panel points. Eyebar / panel point reinforcing

details were mentioned in section E1 (**see Photos E4.1 thru E4.4**). The details include supplemental plates that were added between eyebars, around pins, and between eyebars and horizontal struts between trusses, and then welded to those members. Seal welds, as indicated in the repair plans, were made around the top perimeter of eyebar ends, presumably to prevent moisture intrusion. Such seal welds partially lock the joints and inhibit the ability of the members to rotate as designed, introduce residual stresses in the area of the eyes, and create notches and surface irregularities which could be a point of initiation for fatigue cracks.

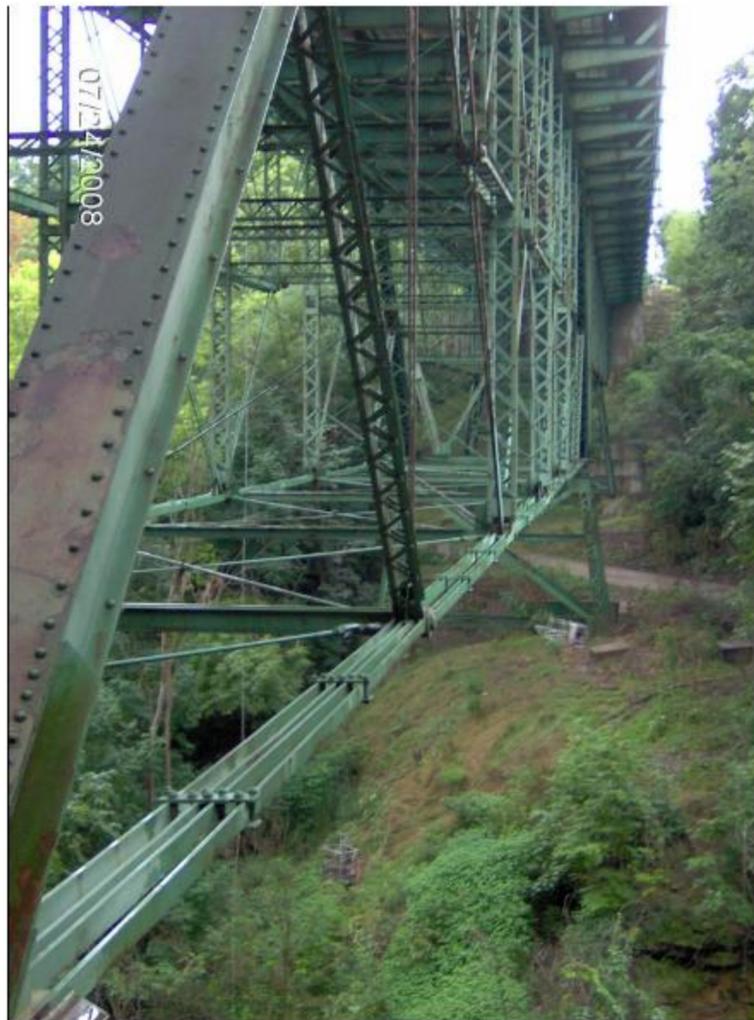
**E5\_1**

Previous inspection reports do not include any comments regarding horizontal or lateral bracing. Bracing members consist of round rods. The 1953 repair plans indicate that new horizontal bracing was installed in all spans. Previous inspection report photos indicate similar details for the horizontal and lateral bracing (**see Photo E5.1**)

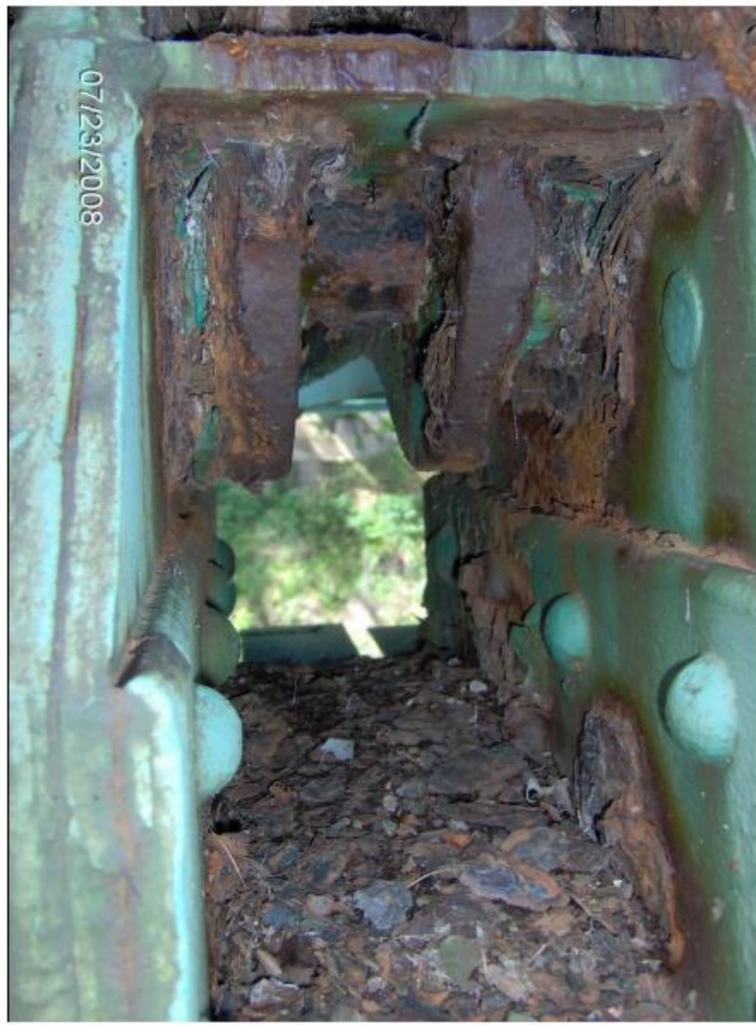
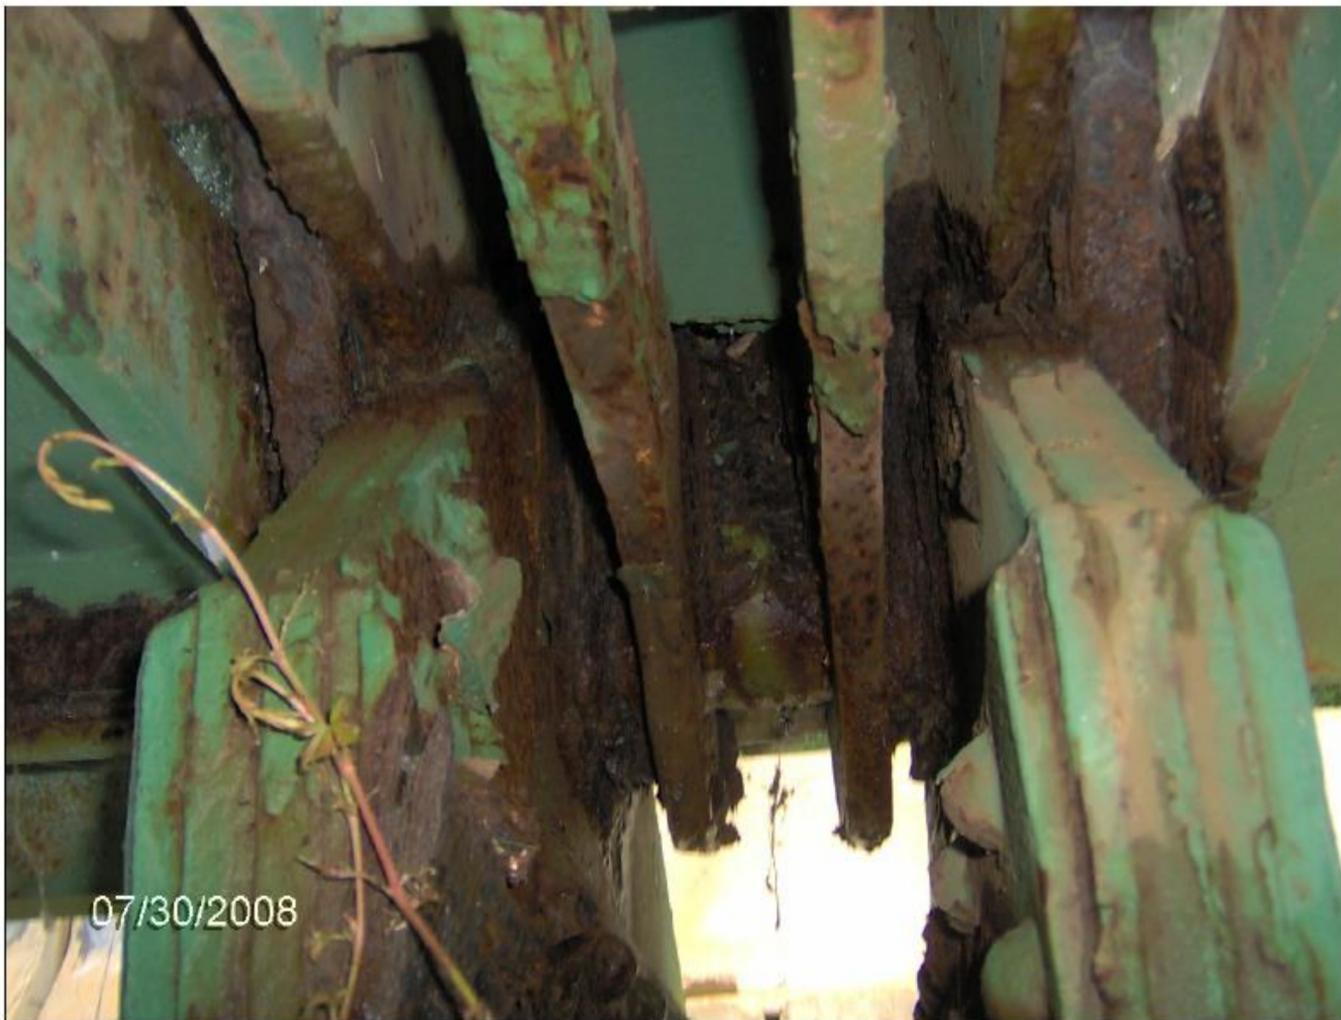
Previous inspection reports do not include any specific notes on truss bearings. The 1953 repair plans include replacement details at the south abutment and for spans 3 and 4. The 1964/1978/1984 repair plans include replacement details for the north end of span 3 and the south end of span 2. Previous inspection photos at abutment bearings indicate heavy surface rust with debris surrounding the bearings (**see Photos E6.1 and E6.2**). Previous inspection report photos at pier truss bearings indicate heavy surface rust on bearings and eyebar ends, with section loss (**see Photos E6.3 and E6.4**).
