# Cascade Bridge Rehabilitation Evaluation

PREPARED FOR  
CITY OF BURLINGTON  
DEPARTMENT OF PUBLIC WORKS

SEPTEMBER 2012

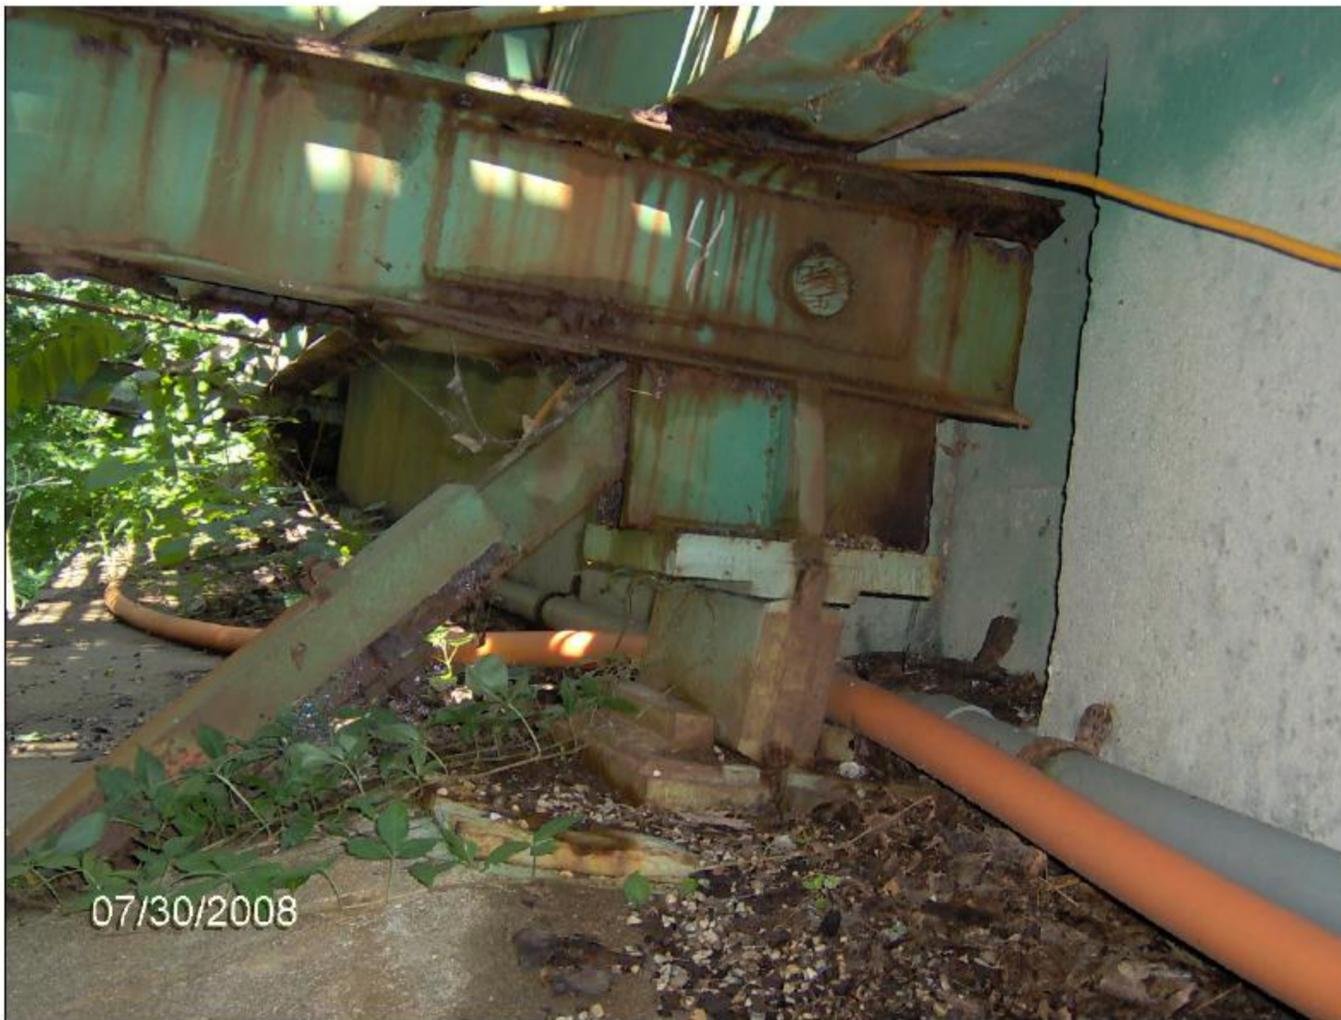
**E6\_1**

A1, A2	Steel bridge roadway deck
A3	South abutment deck expansion joint
A4	Pier 1 deck expansion joint
A5	North abutment deck expansion joint
B1	Sidewalk deterioration
C1	Sidewalk rail
D1 thru D6	Floorbeam corrosion and section loss
D7	Deck stringer corrosion and section loss
D8	Sidewalk framing corrosion and section loss
E1.1	Damaged eyebar
E1.2 thru E1.10	Eyebar corrosion and section loss at panel points
E1.11 thru E1.13	Previous repair eyebar reinforcement
E1.14	Previous repair seal welds at panel points
E2.1, E2.2	Previous repair rod reinforcement
E3.1 thru E3.3	Built-up member corrosion and section loss
E3.4	Damaged lacing on built-up member
E3.5	Missing rivet from built-up member
E3.6 thru E3.10	Pack rust distortion on built-up members
E4.1 thru E4.4	Eyebar / panel point reinforcing details
E5.1	Typical horizontal and lateral braces
E6.1, E6.2	Heavy surface rust at bearings
E6.3, E6.4	Section loss at truss bearings
